**EXECUTIVE SUMMARY
PRE ACQUISITION
SURVEY REPORT**

**OCKBROOK SCHOOL
THE SETTLEMENT
OCKBROOK
DERBYSHIRE
DE72 3RJ**

Date: 16 September 2022

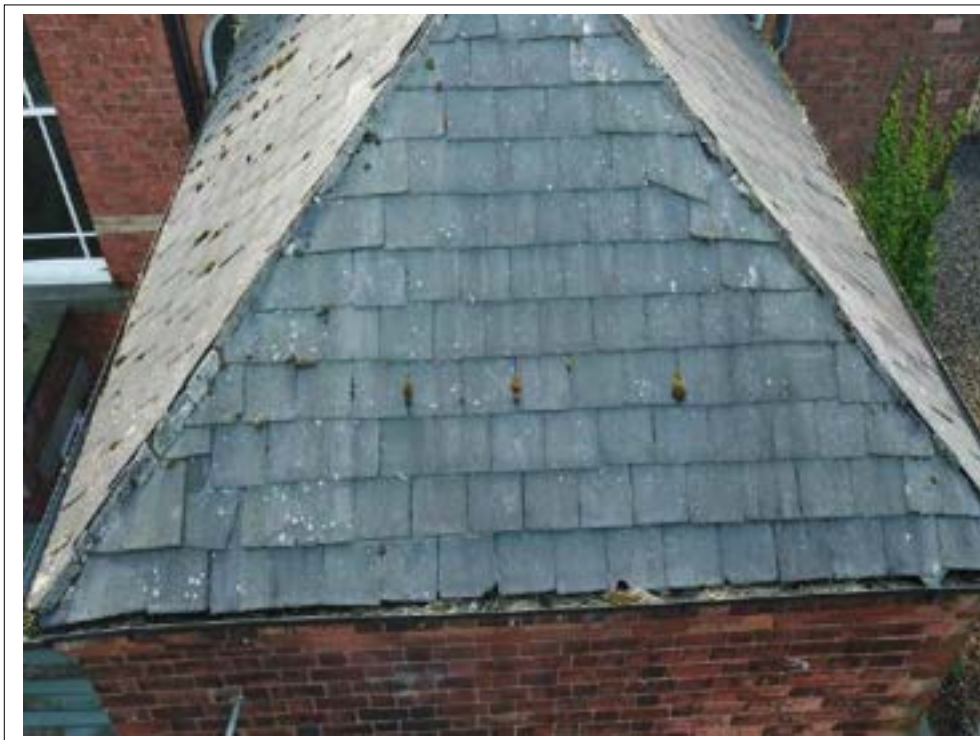
5. Missing hip tiles, slipped slates generally.

To the southwest two storey extension no hip tiles have been installed, this is a poor detail leaving the joint exposed and we recommend hip tiles are installed as part of the wider roof overhaul.

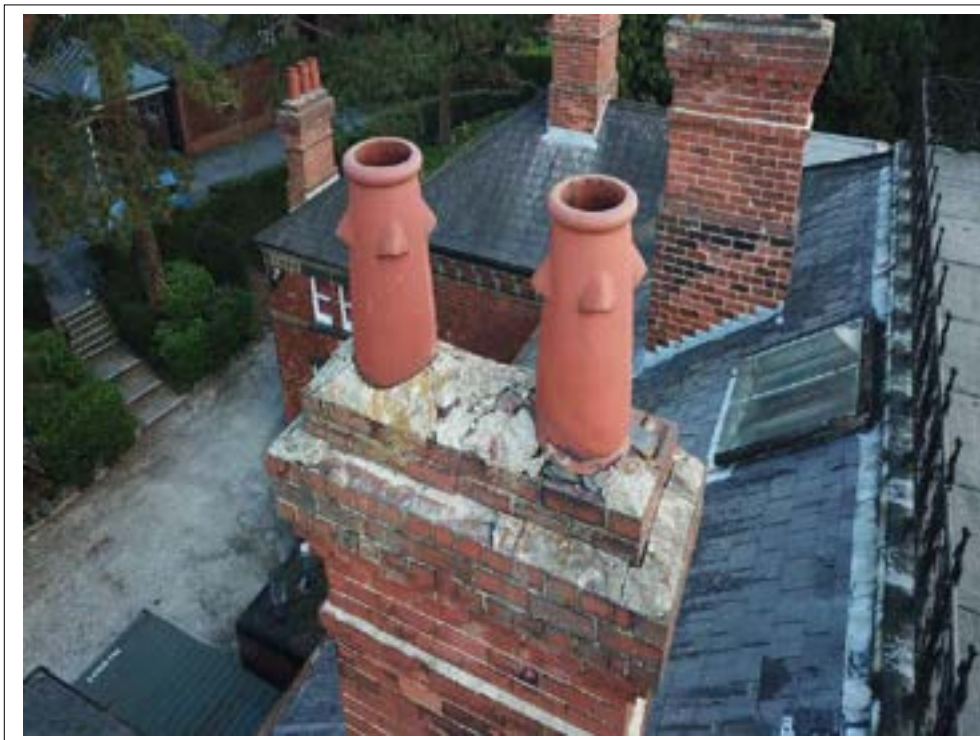
7. Cracked and friable cement flaunching.

Cement flashings to brick chimneys are generally cracked and friable with 1 No. chimney to the south side being in particularly poor condition, again these should be renewed in line with the planned maintenance works.

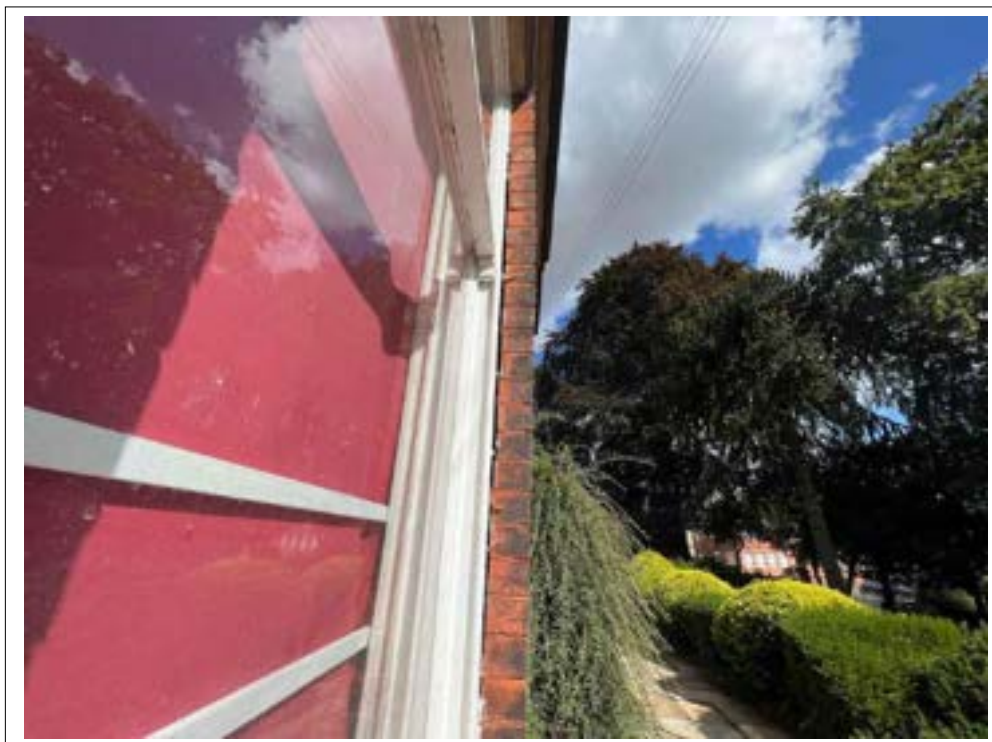
9. Bowing noted to brick pier to East elevation.

To the east elevation some minor structural movement was noted to the brick pier at ground floor level central to the two large sliding sash windows. When viewed side-on, it could be seen that the brick pier is being pushed outwards and structural advice should be sought on this matter as well.

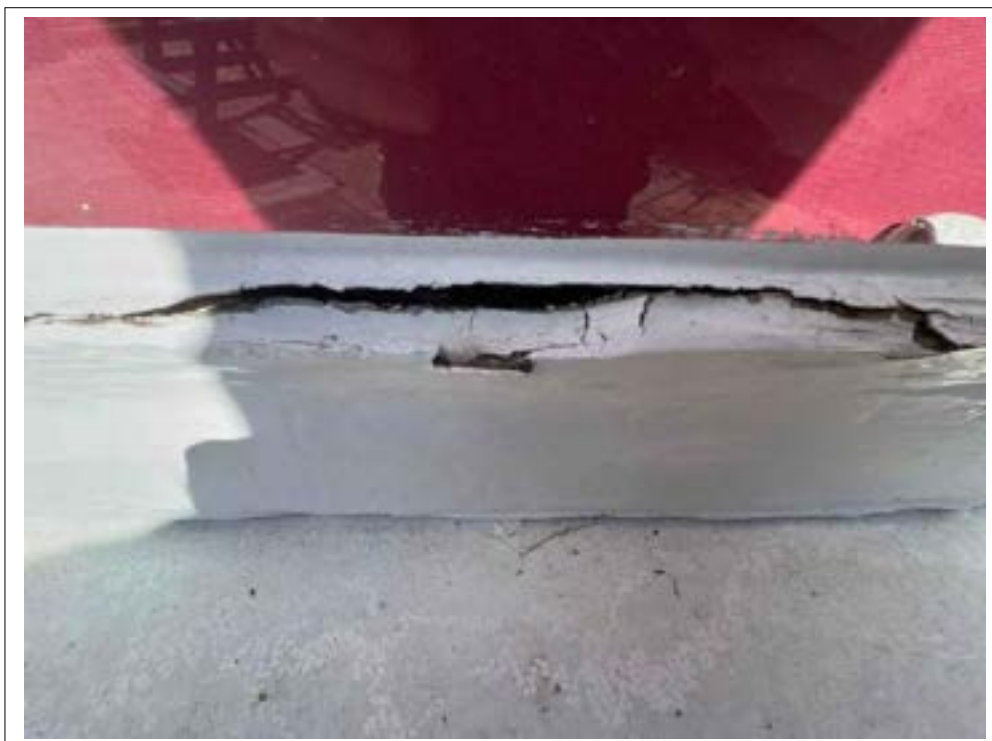
10. Wet rot to lower window cill.

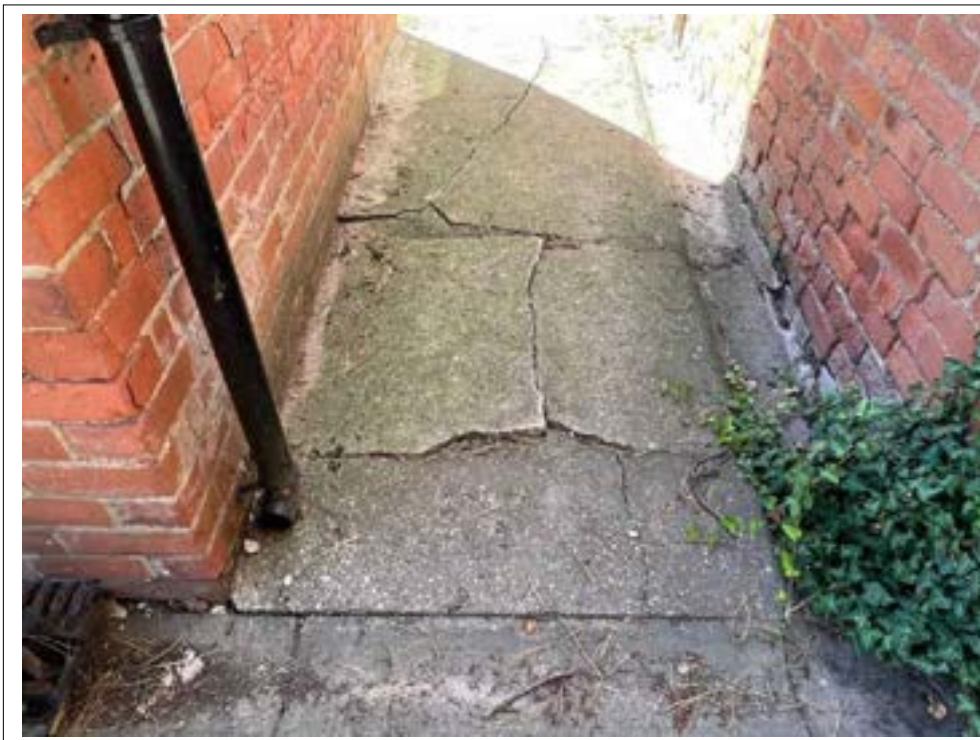
11. Concrete pathway damaged by root system.

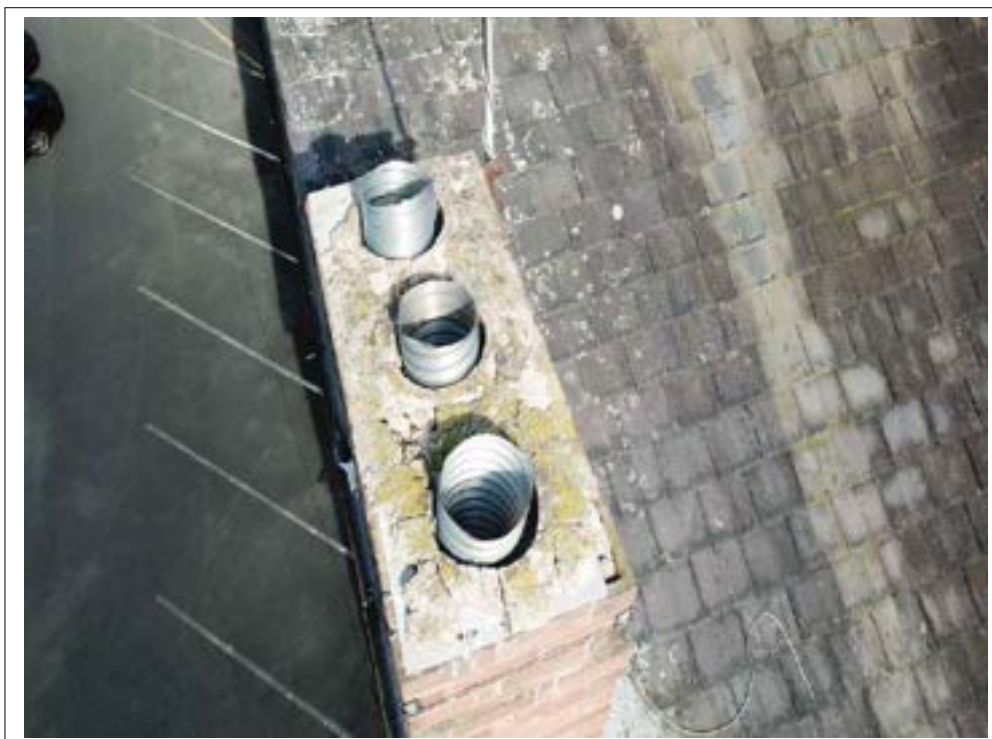
22. Cracked flaunching to chimney.

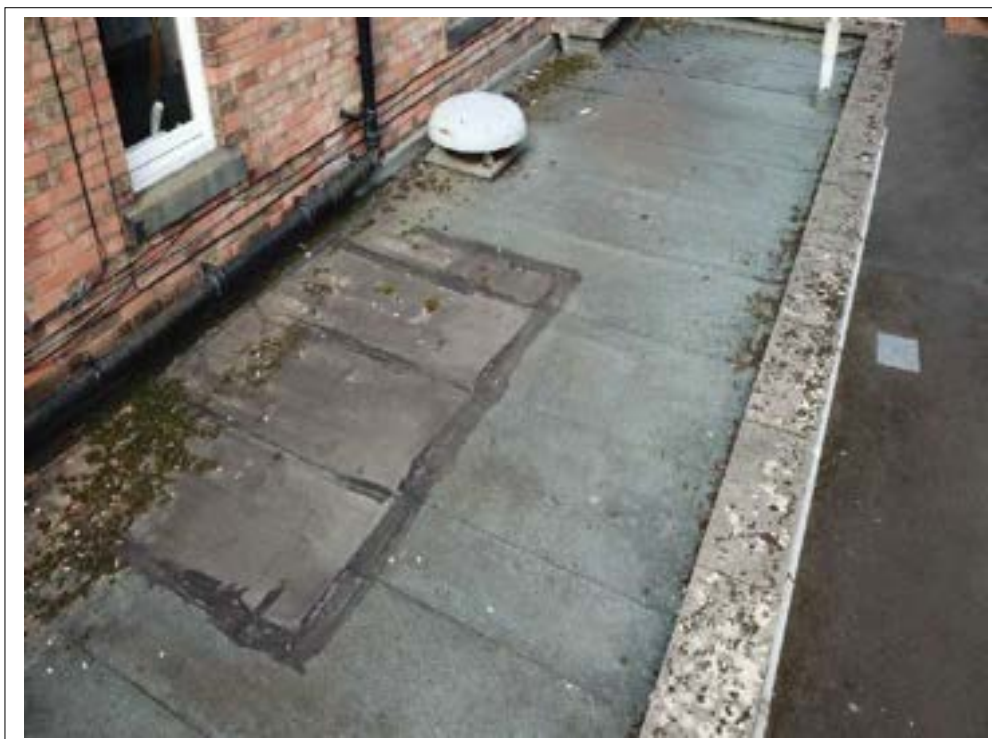
24. Evidence of patch repairs to flat roof.

Small felt roof covering to single storey extension to the north has had bitumen patch repairs. These appear inadequate and surface crazing is noted to both patch repair and main roof substrate. Consideration should be given to an overlay system or similar in this location.

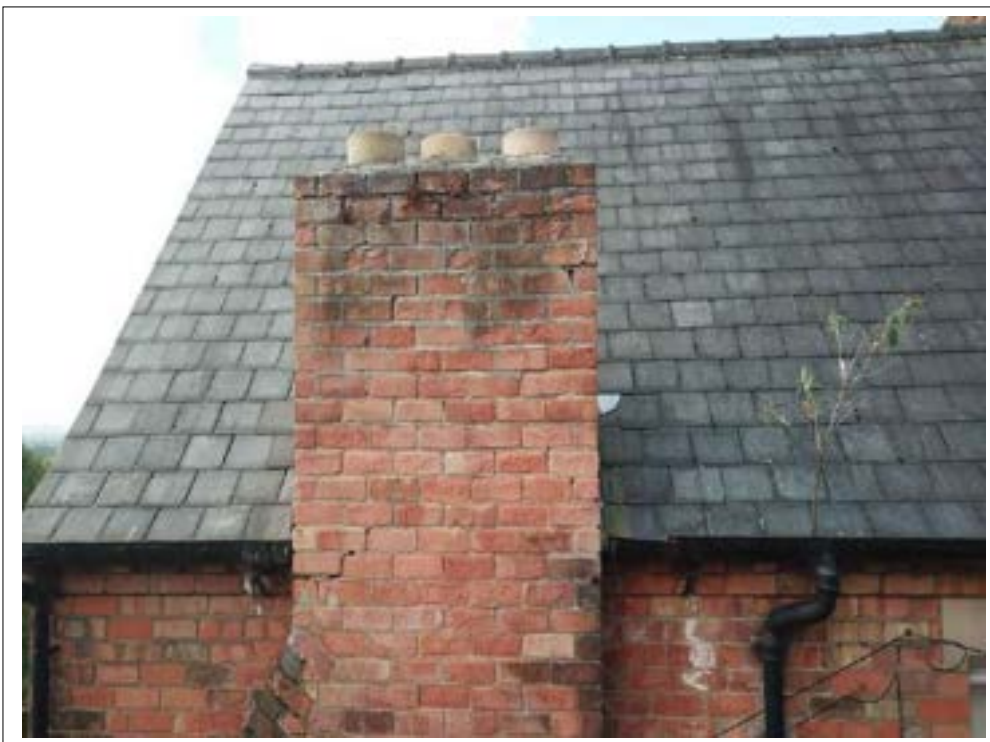
25. Cracking to chimney breast.

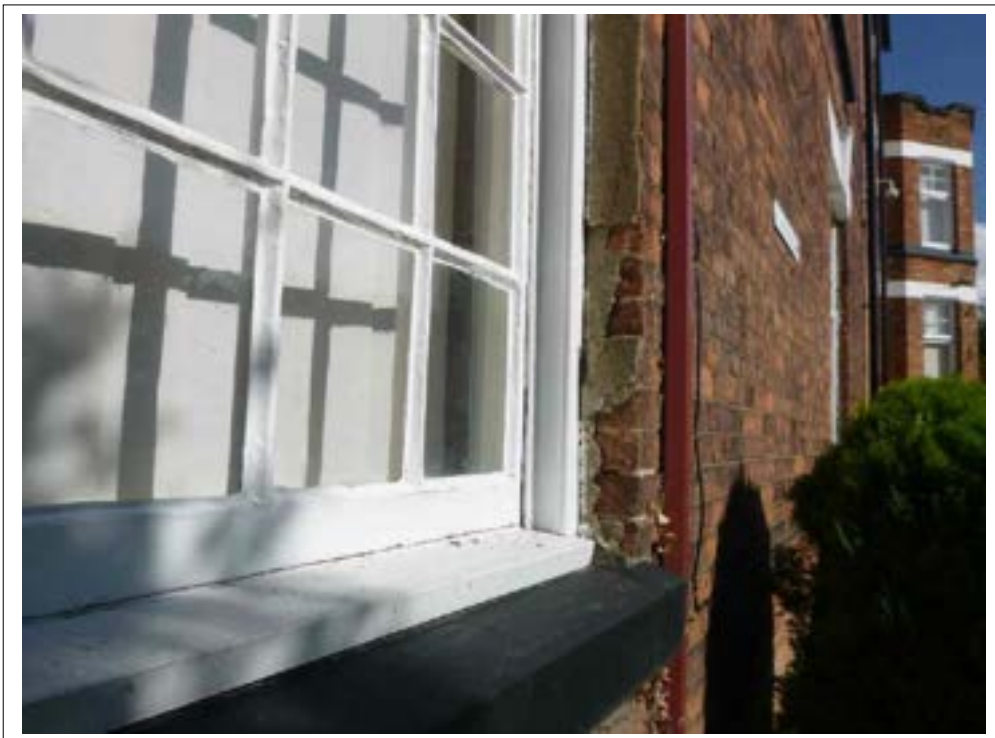
27. Spalling to window surround.

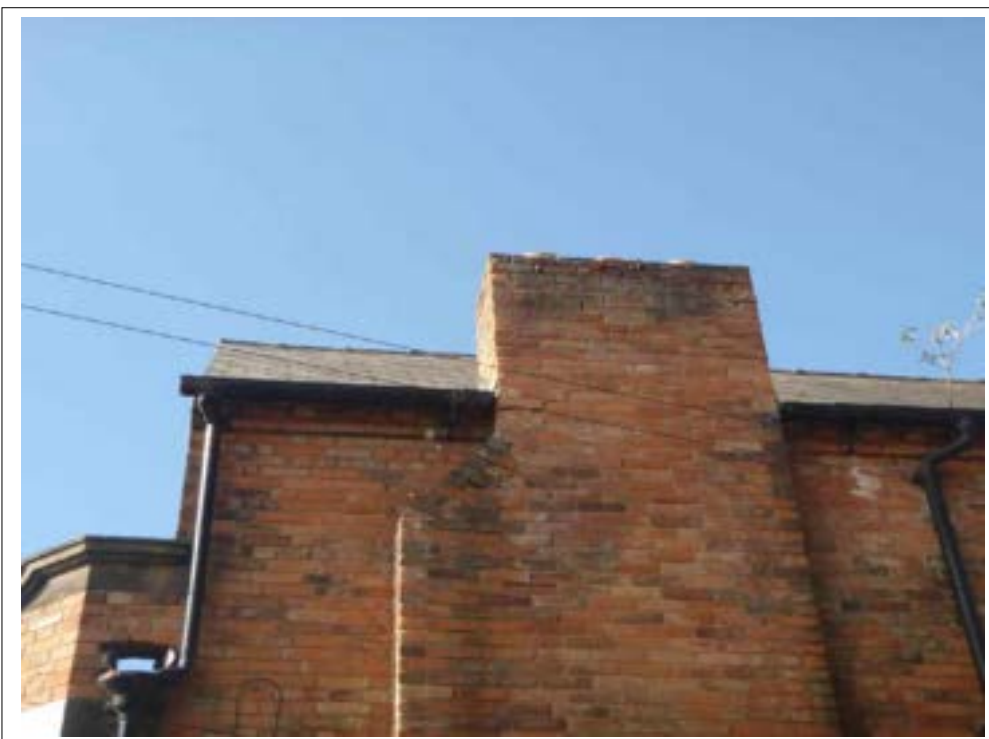
30. Cracking to chimney breast.

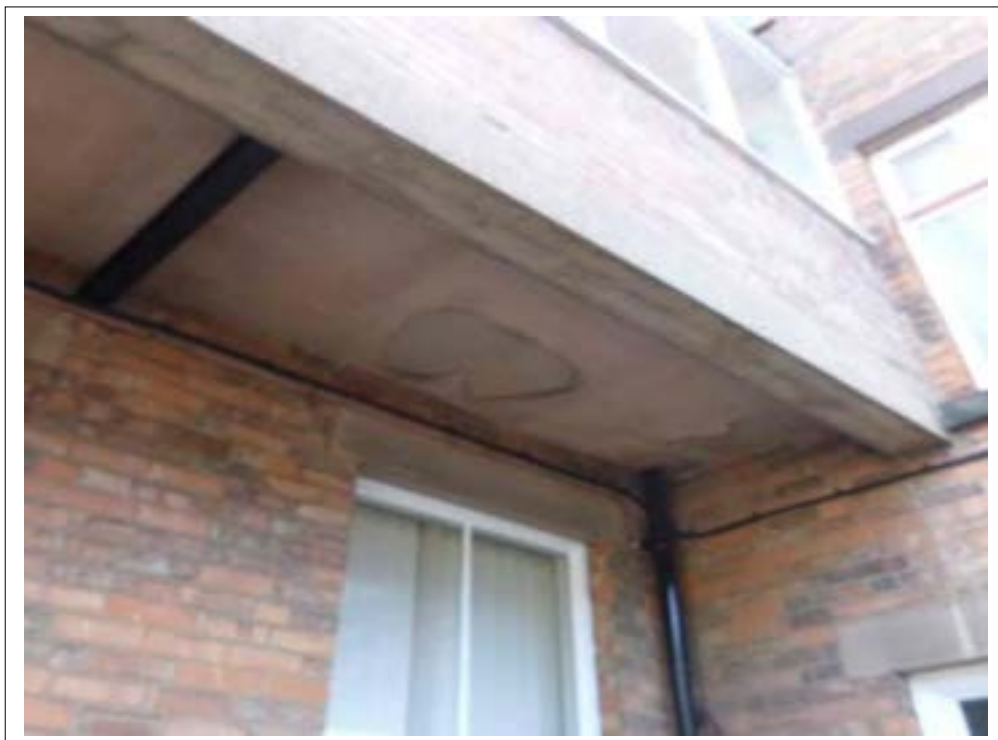
33. Spalling to soffit.

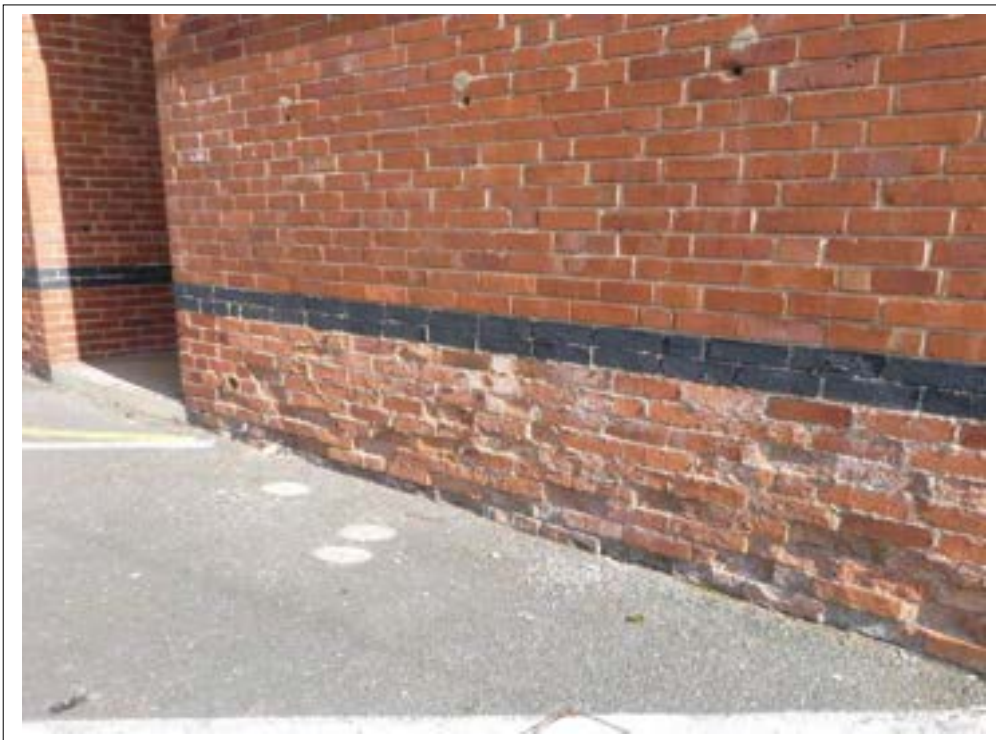
39. Frost erosion to brick masonry.

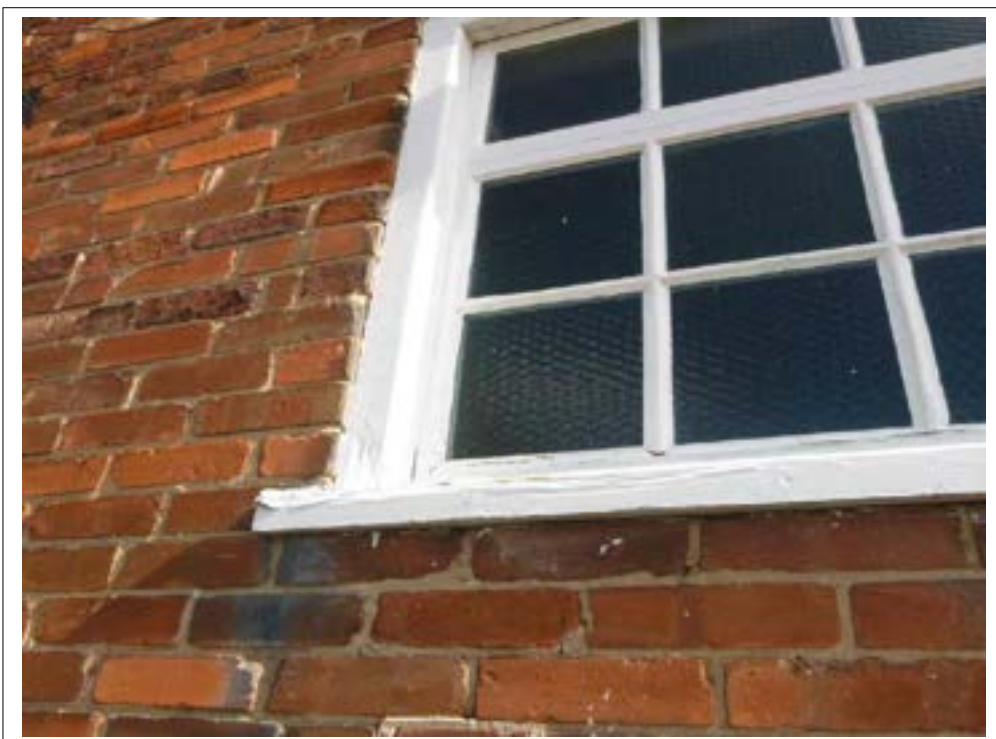
40. Decay to lower window cill.

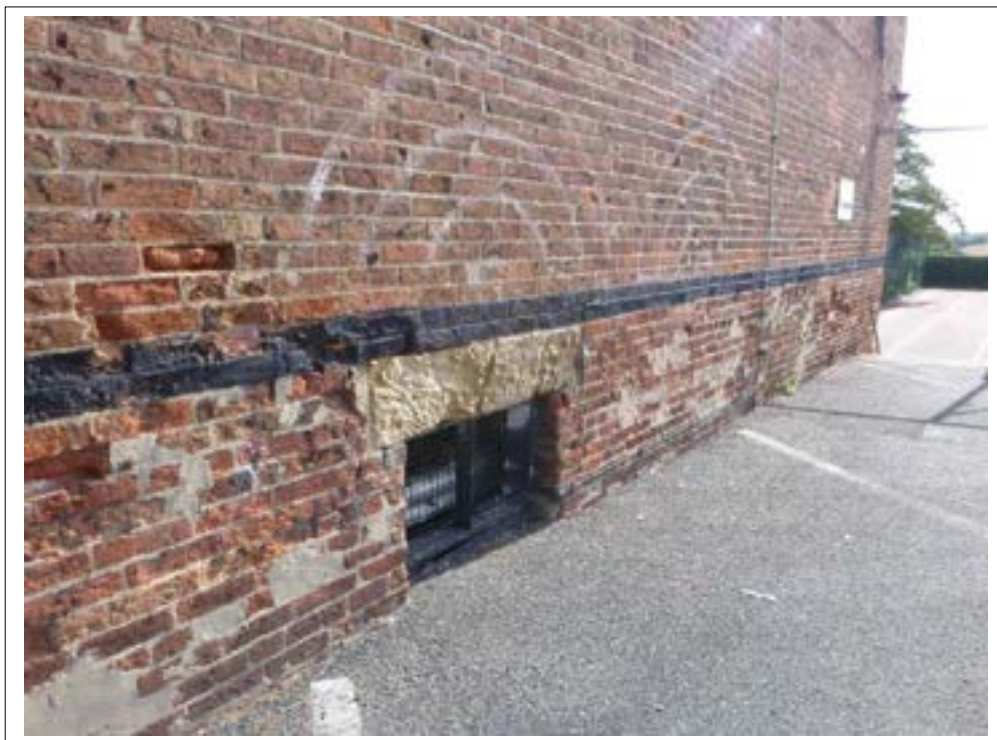
41. Frost erosion to brick masonry.

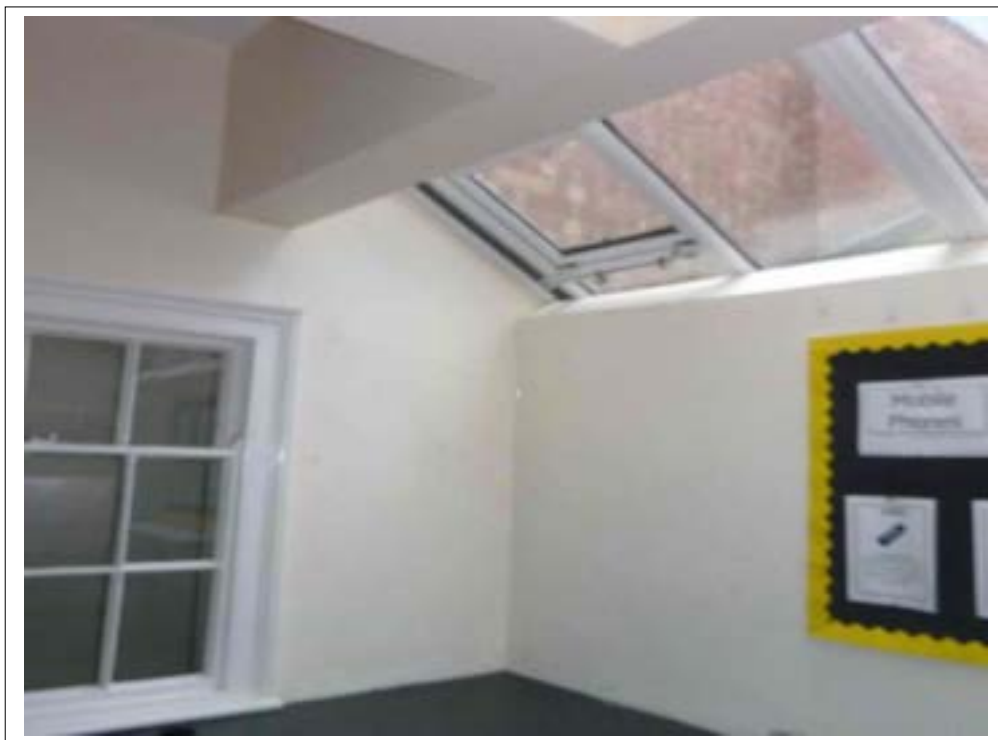
50. Light well, settlement cracking to inner wall.

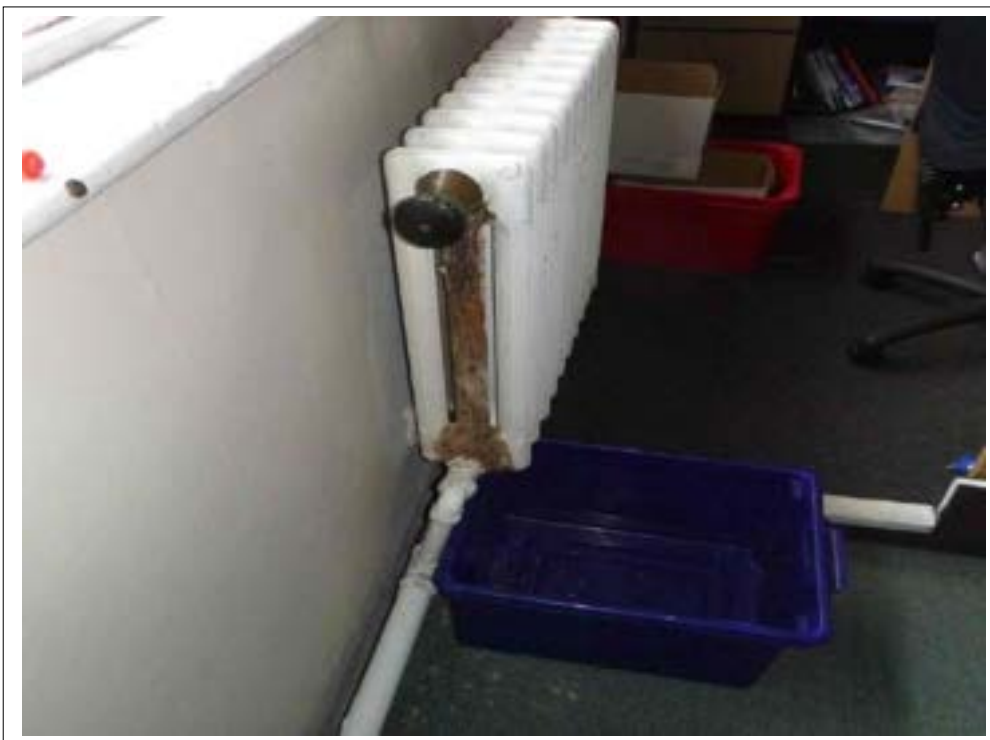
58. Defective valve to radiator.

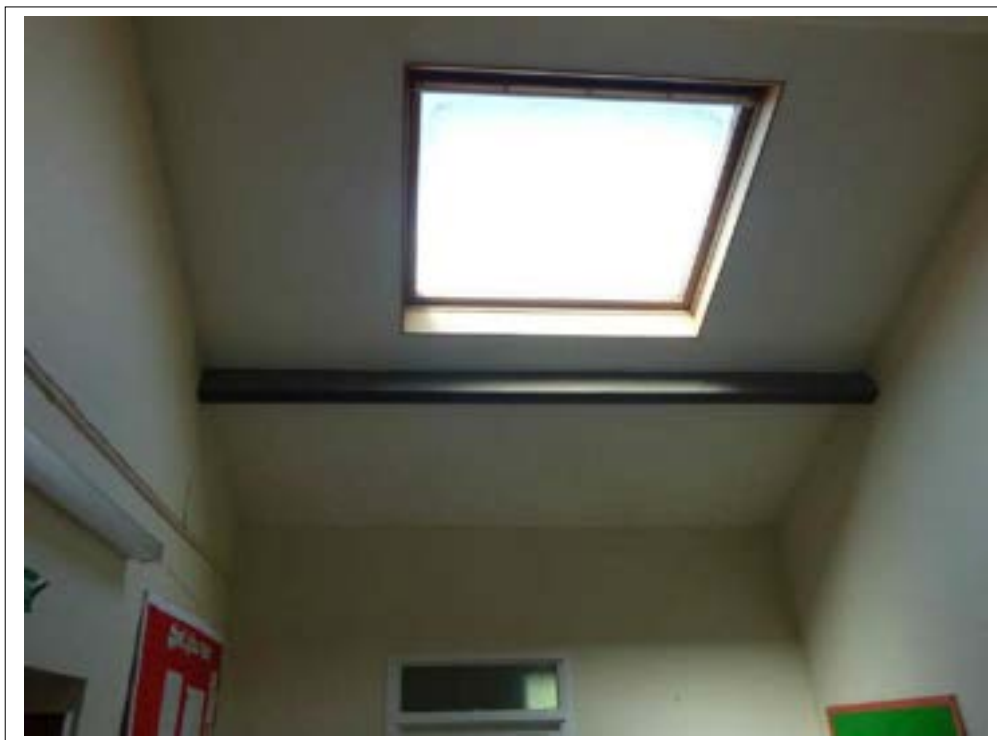
62. Localised water staining around rooflight.

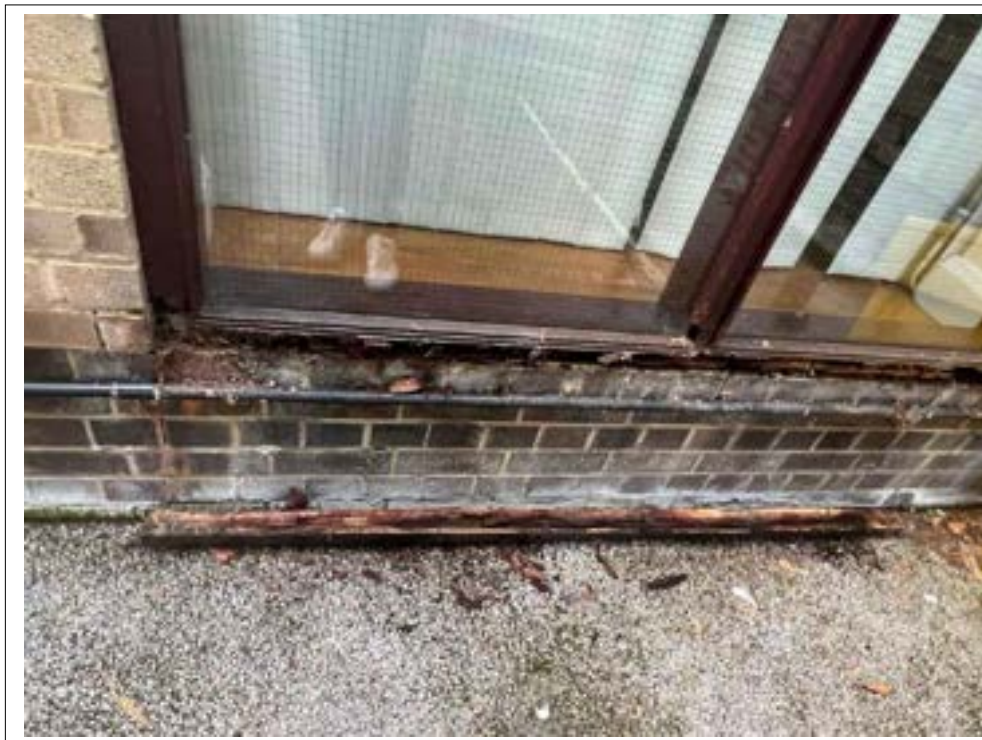
69. Wet rot to window cill.

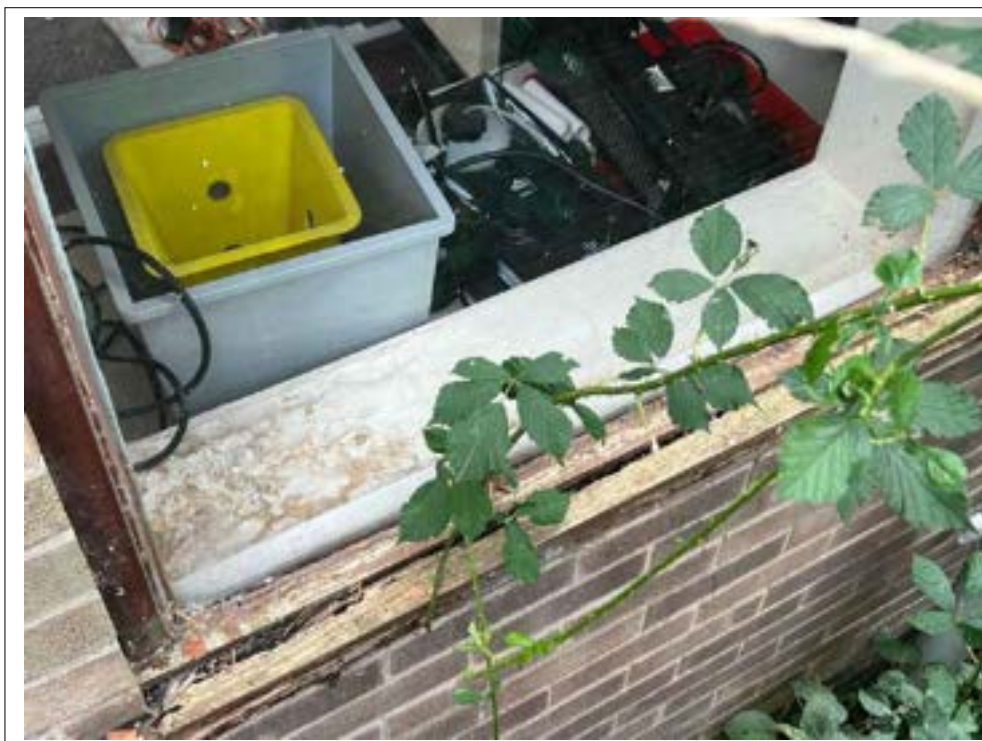
70. Wet rot to window cill.

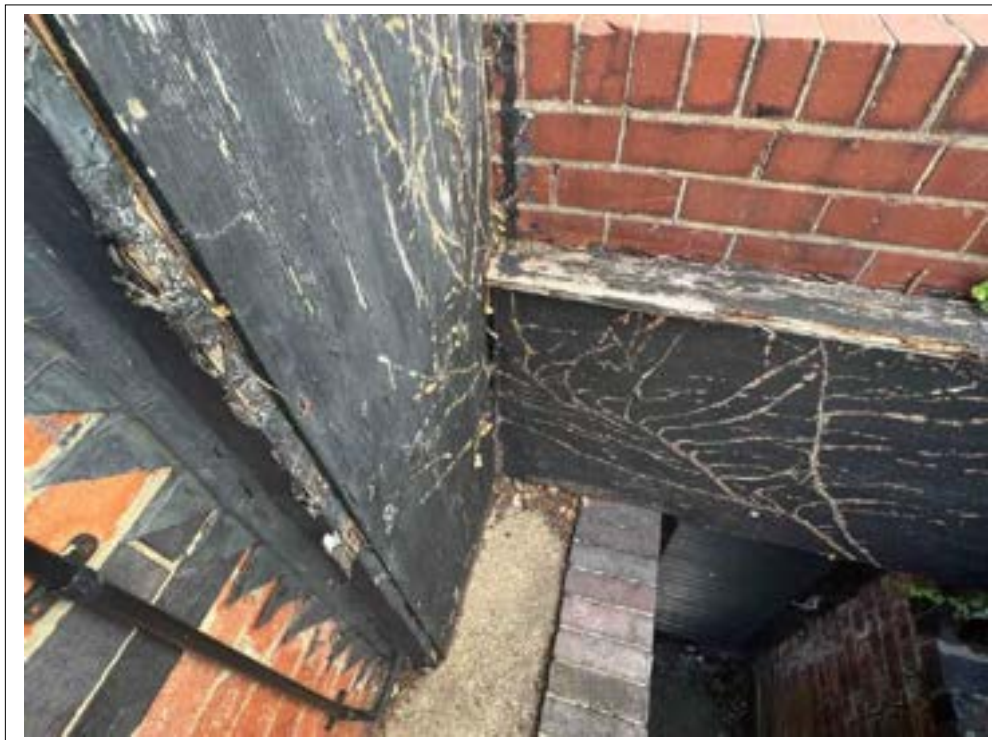
71. Wet rot to timber service housing.

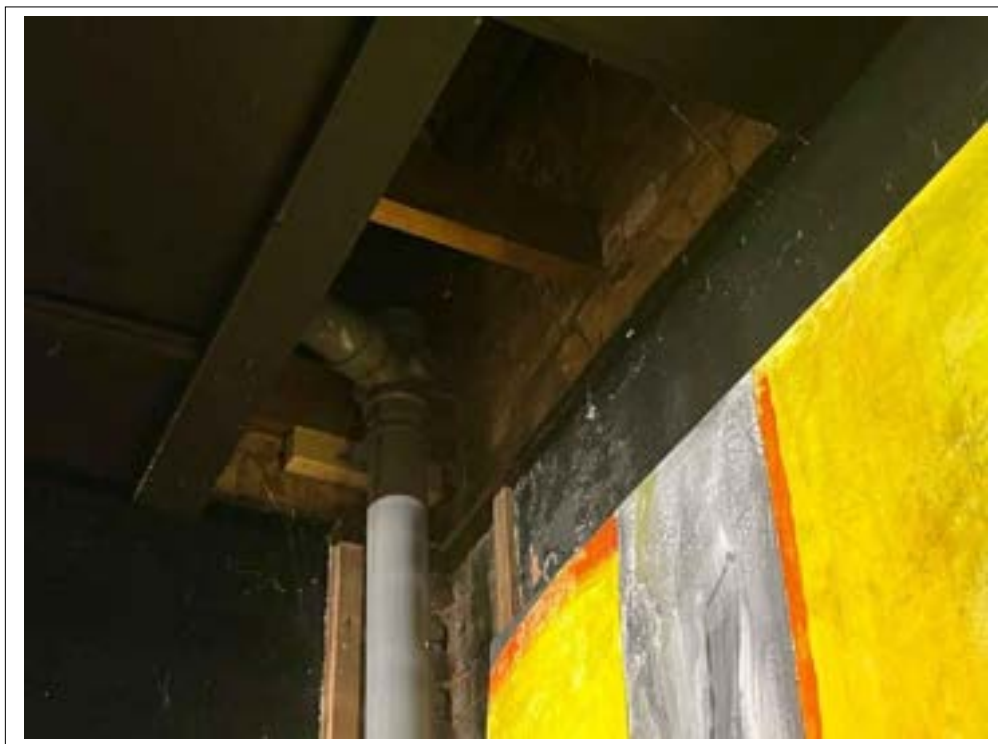
75. Ingress noted internally from internal outlet.

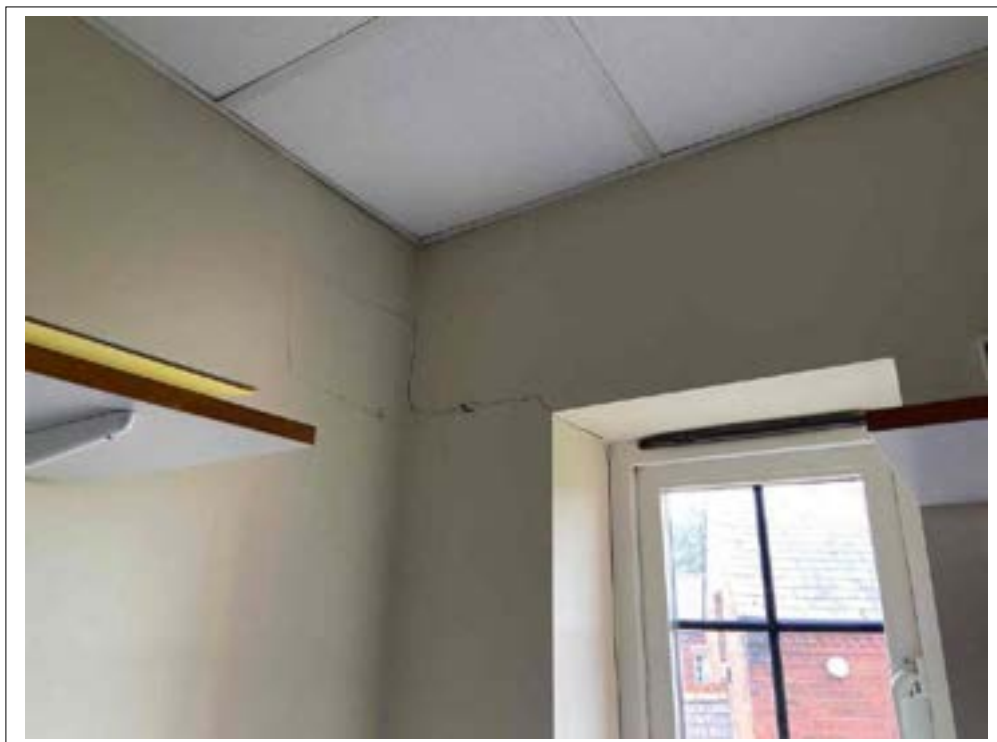
82. Settlement cracking to south east corner.

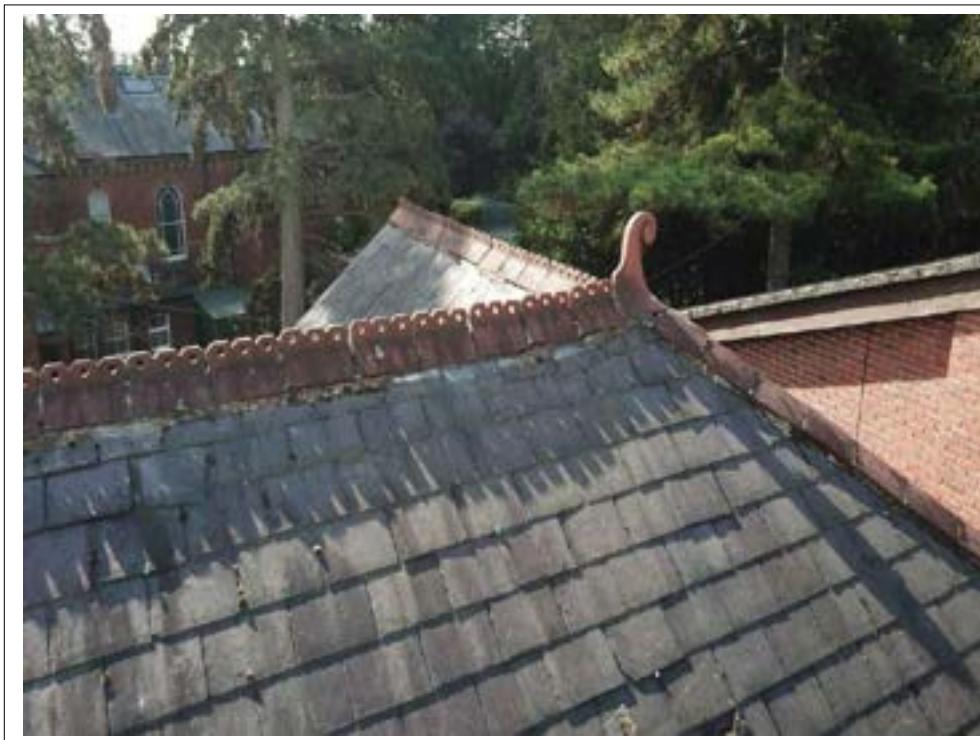
89. Cracked and friable mortar bedding to ridge tiles.

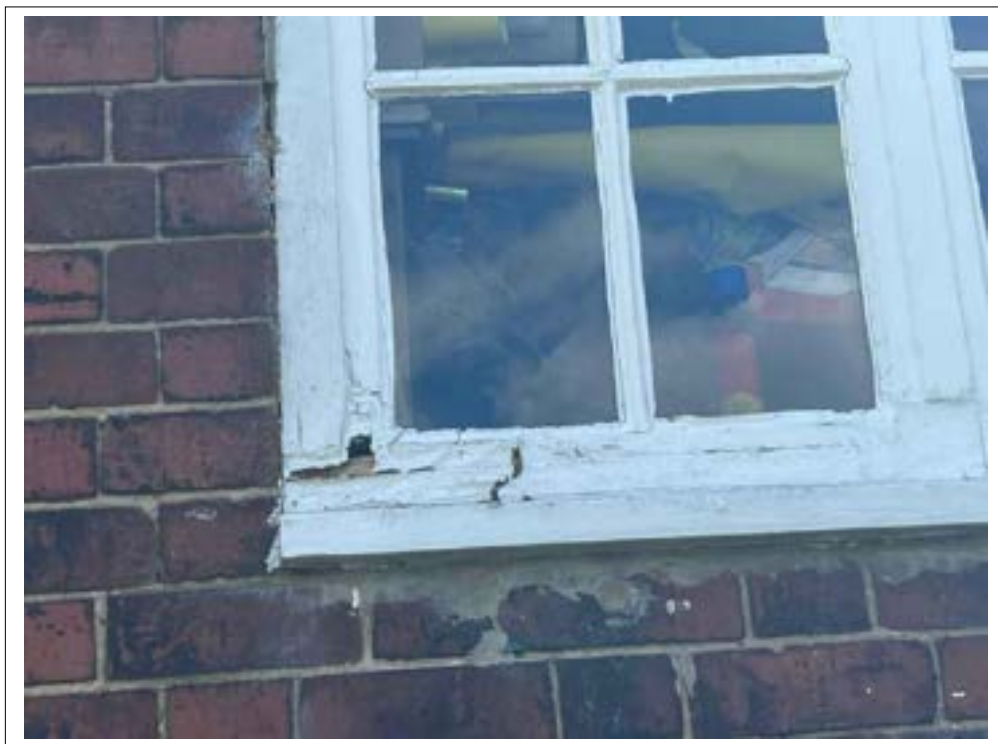
91. Wet rot to lower cills and frame.

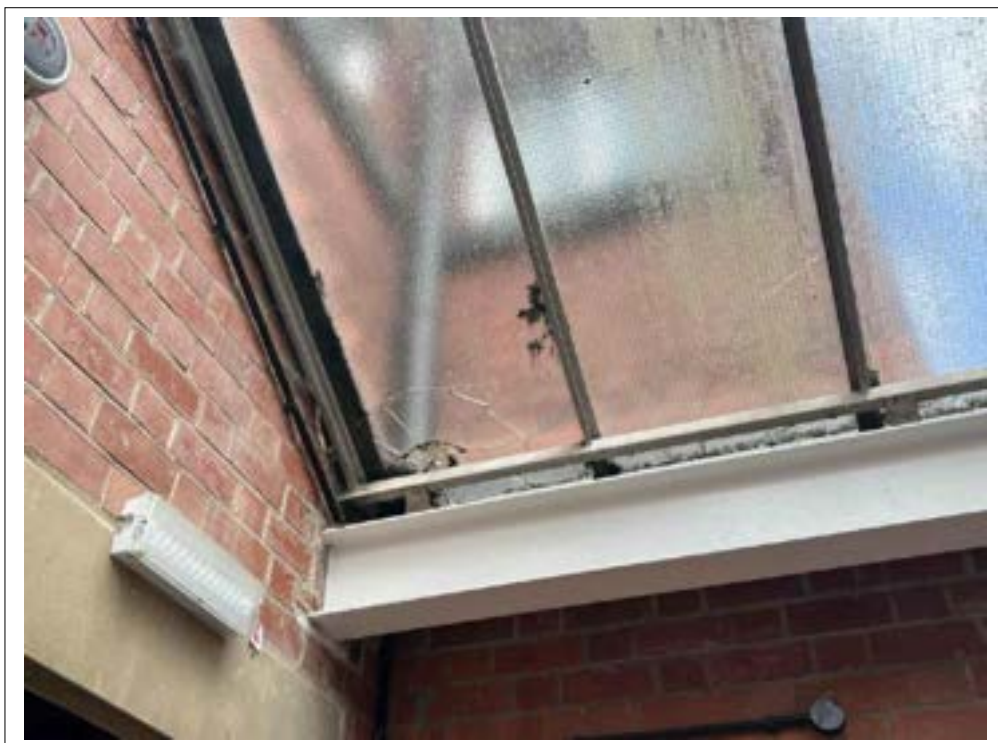
92. Cracked glazing to glazed canopy.

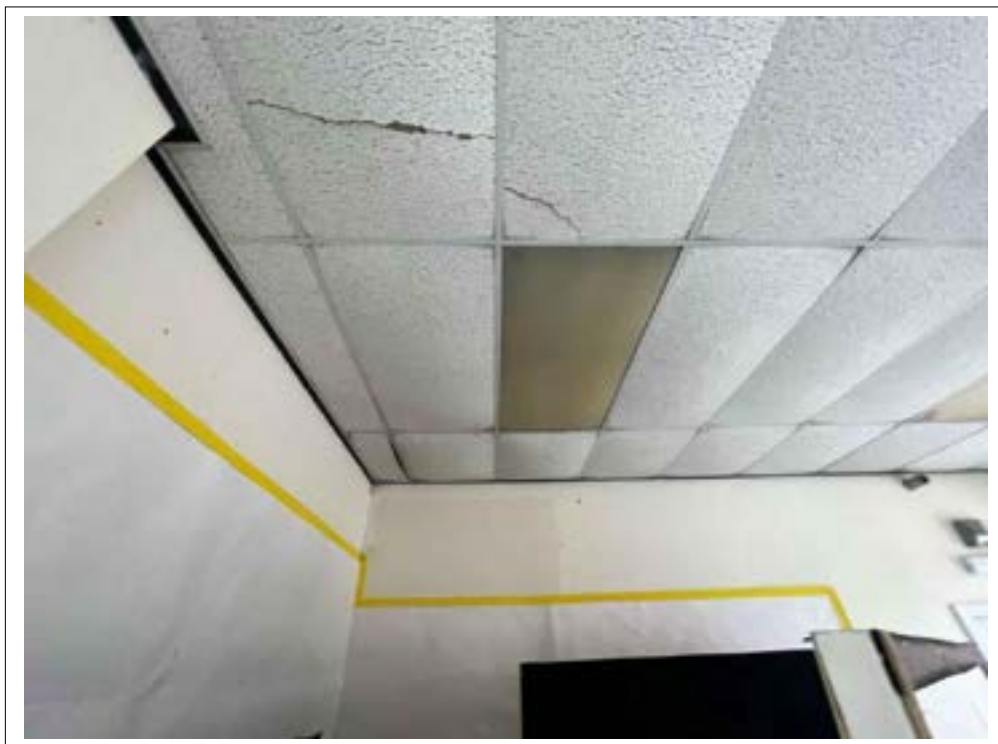
93. Cracked ceiling tiles with undulations noted generally.

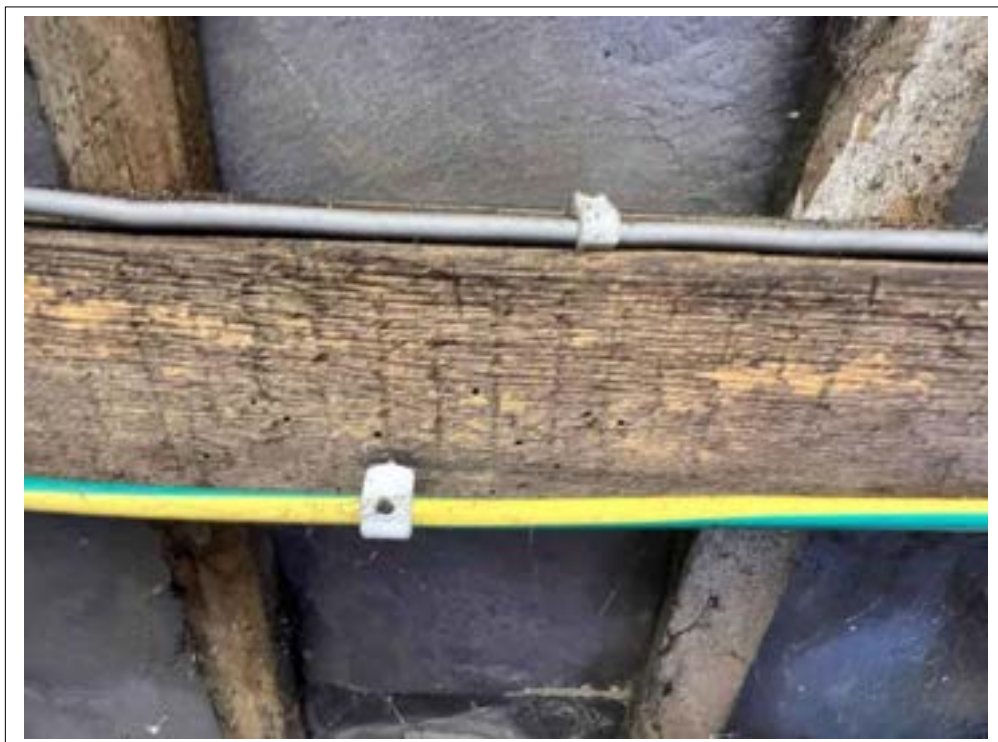
97. Flight holes noted to plant room roof structure.

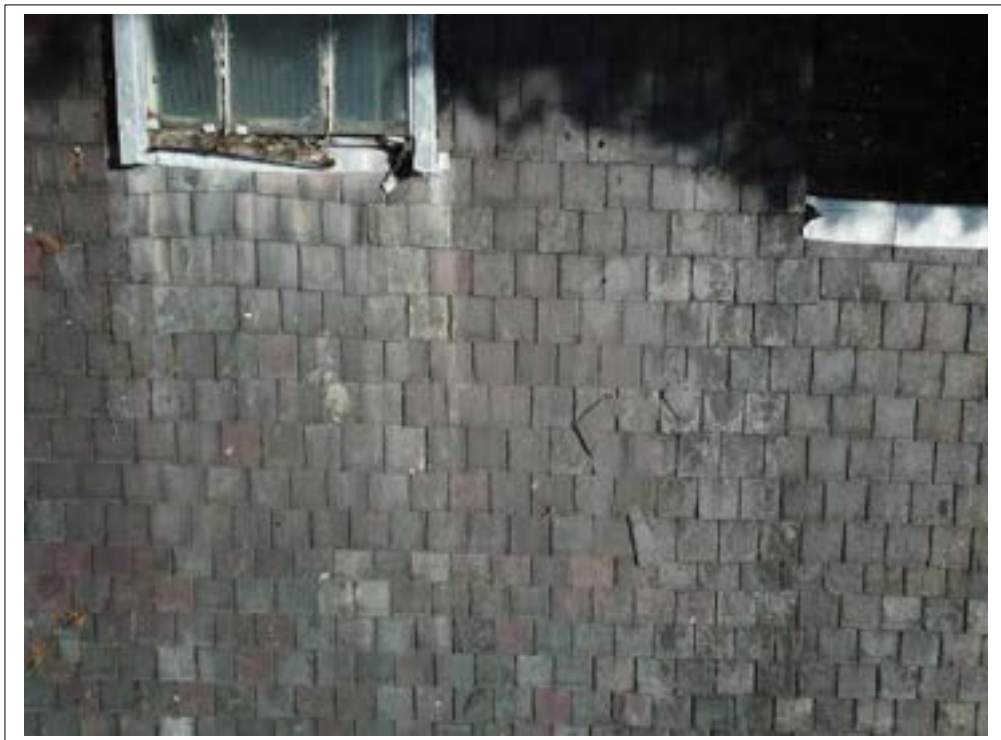
108. Slipped slates to South extension, decayed rooflight.

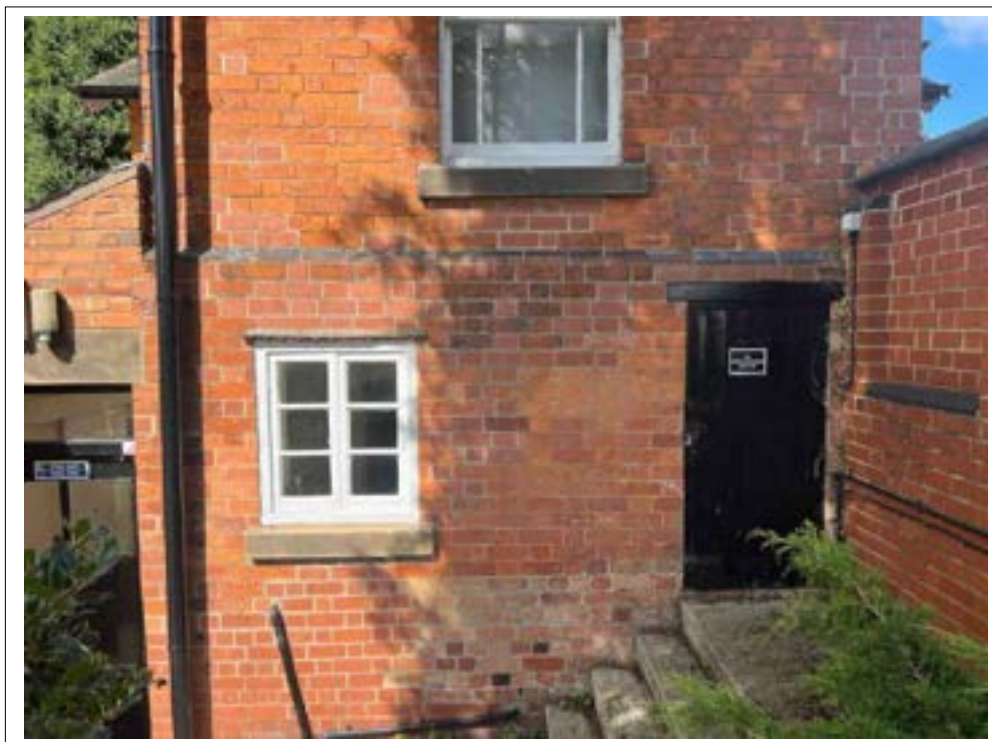
110. Movement noted to low level brickwork.

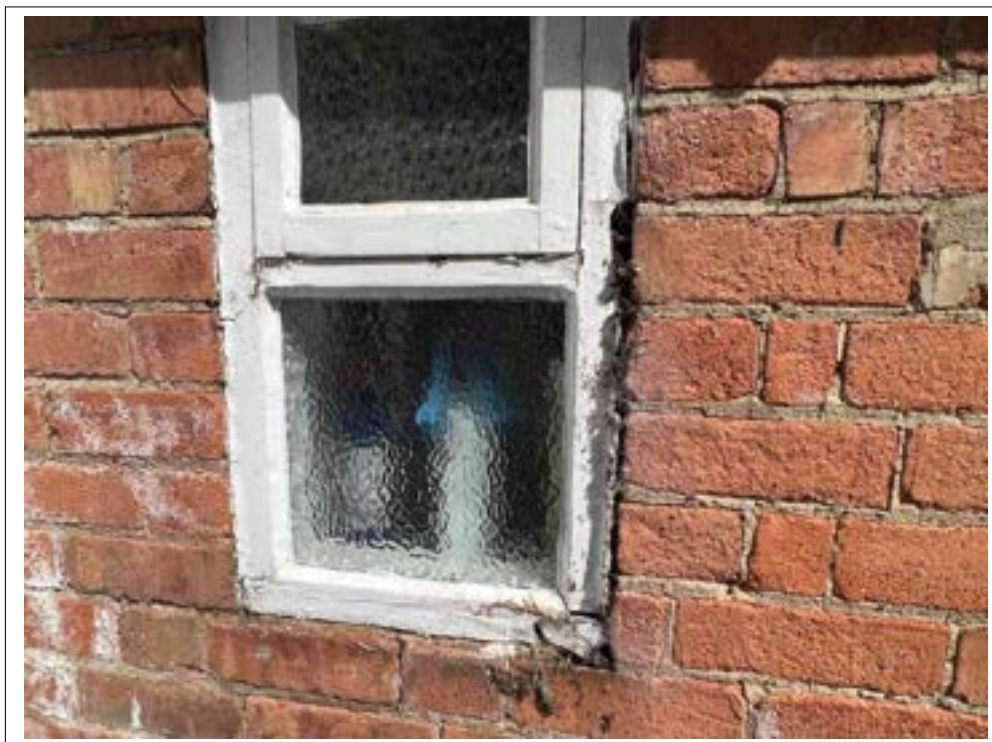
112. Wet rot to timber window.
