**EXECUTIVE SUMMARY
PRE ACQUISITION
SURVEY REPORT**

**OCKBROOK SCHOOL
THE SETTLEMENT
OCKBROOK
DERBYSHIRE
DE72 3RJ**

Date: 16 September 2022

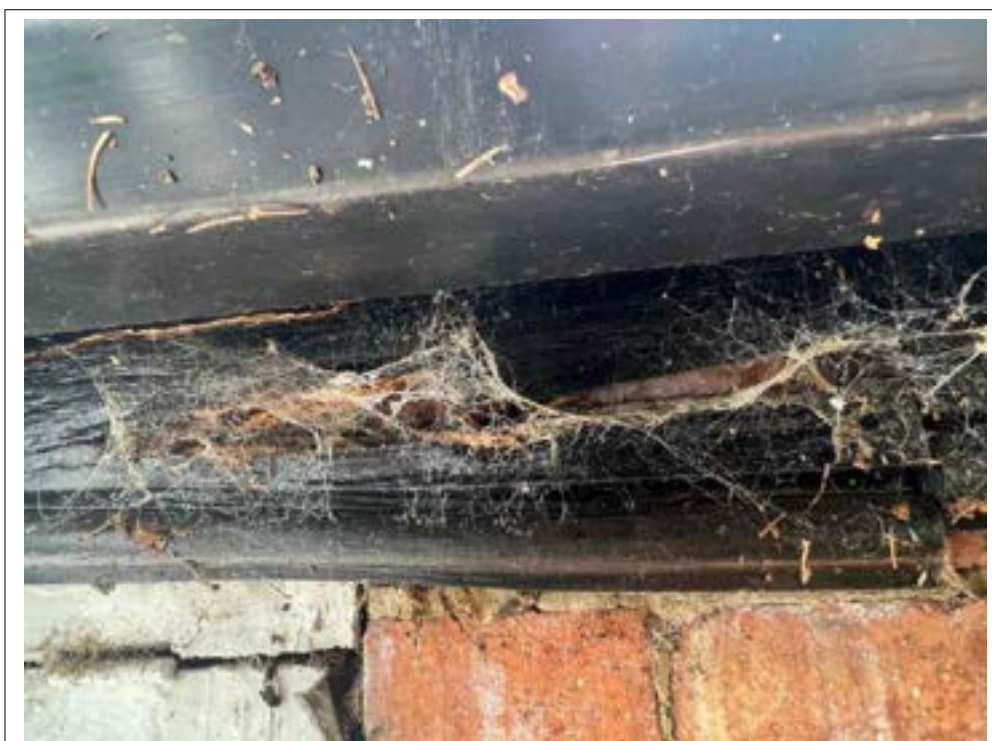
113. Wet rot to timber fascia.

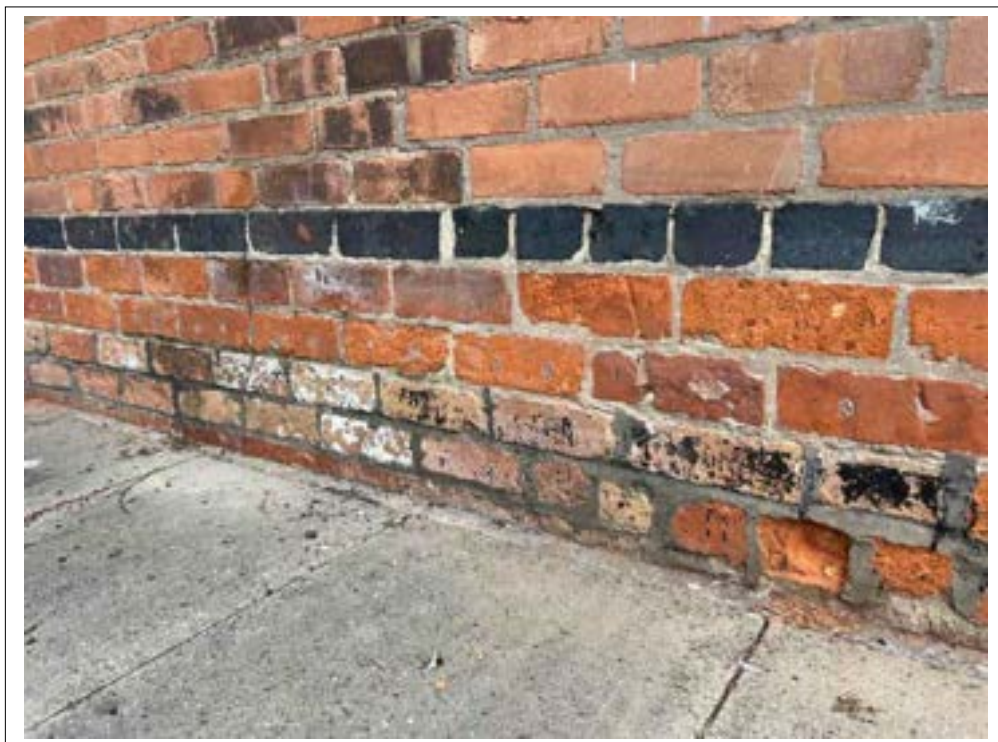
114. Retrofit chemically injected DPC.

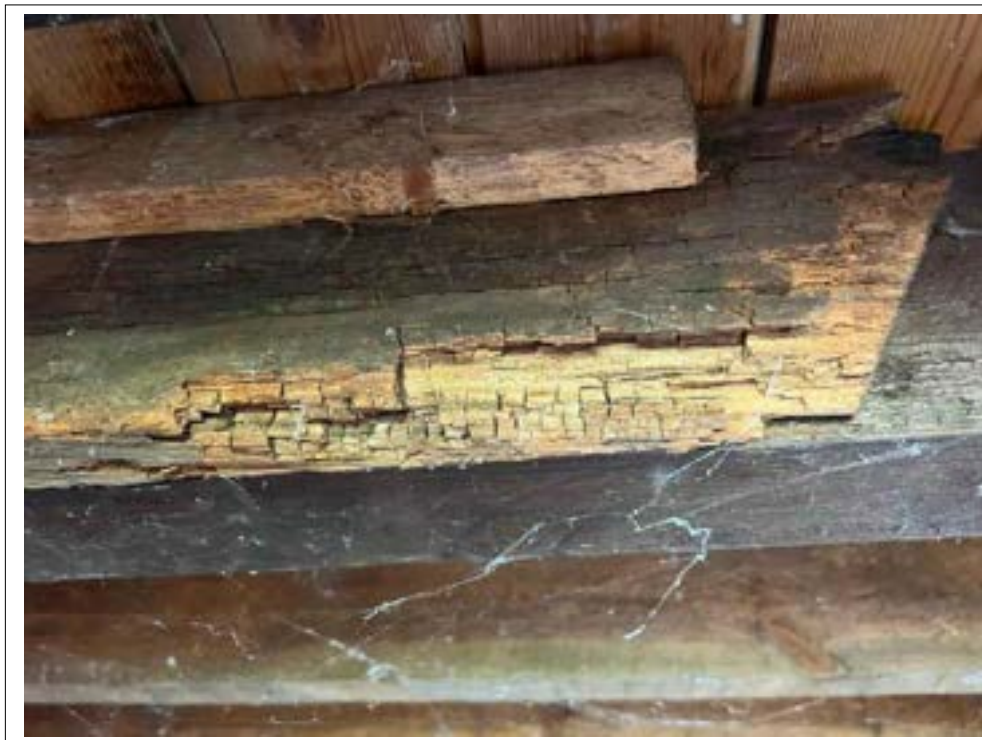
116. Decay noted to suspended ground floor timbers,

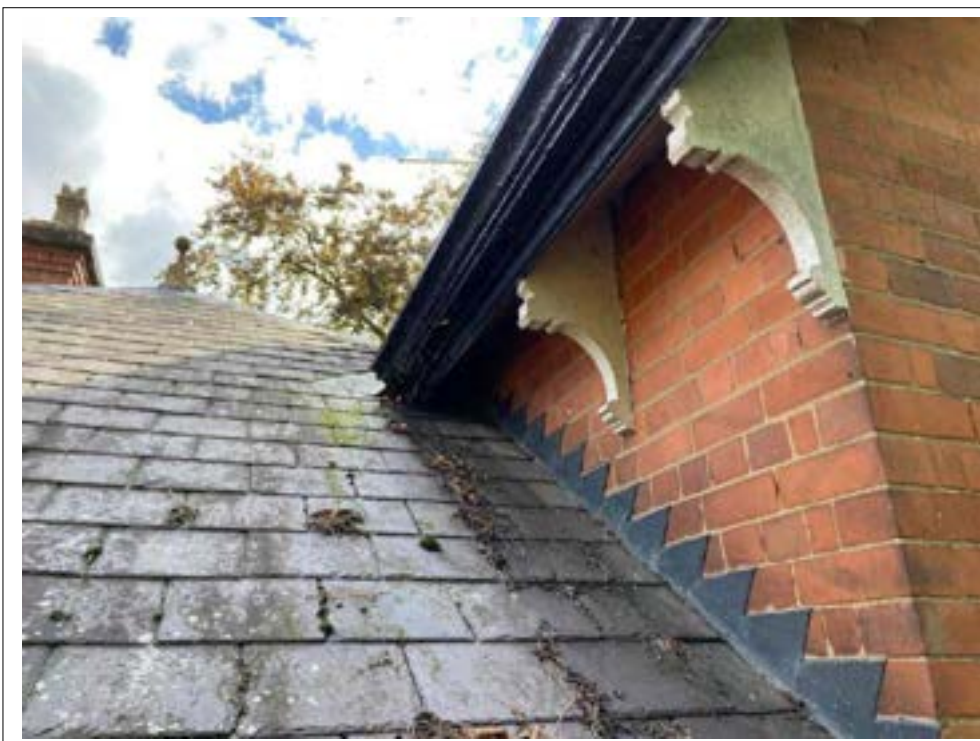
119. Decay to gutter lines.

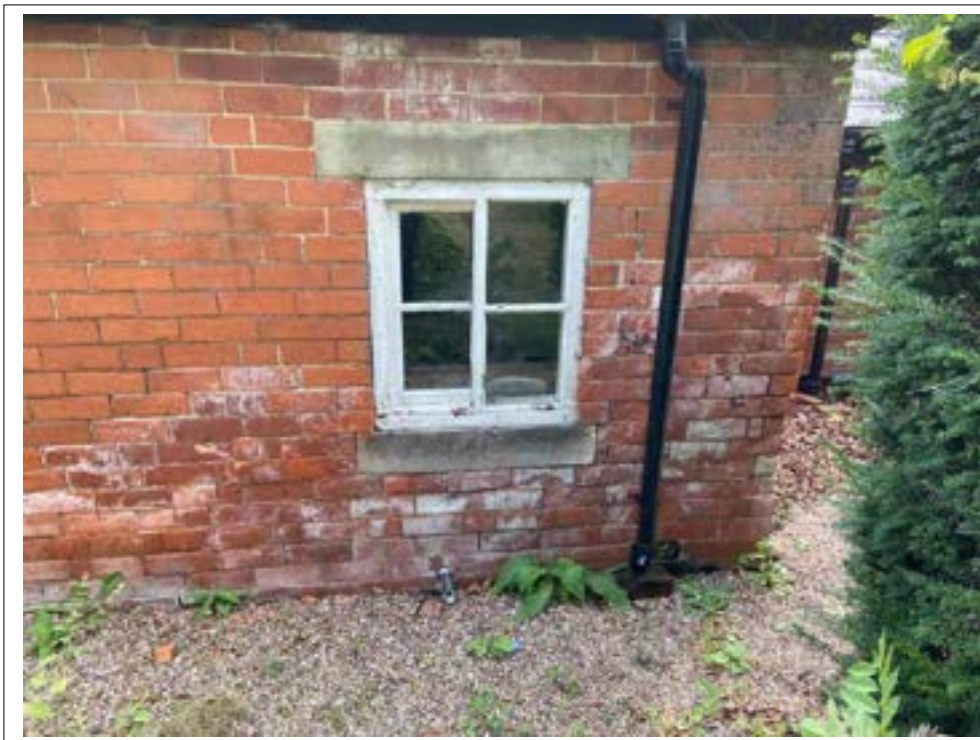
122. Rear of outhouse, efflorescence noted to brickwork.

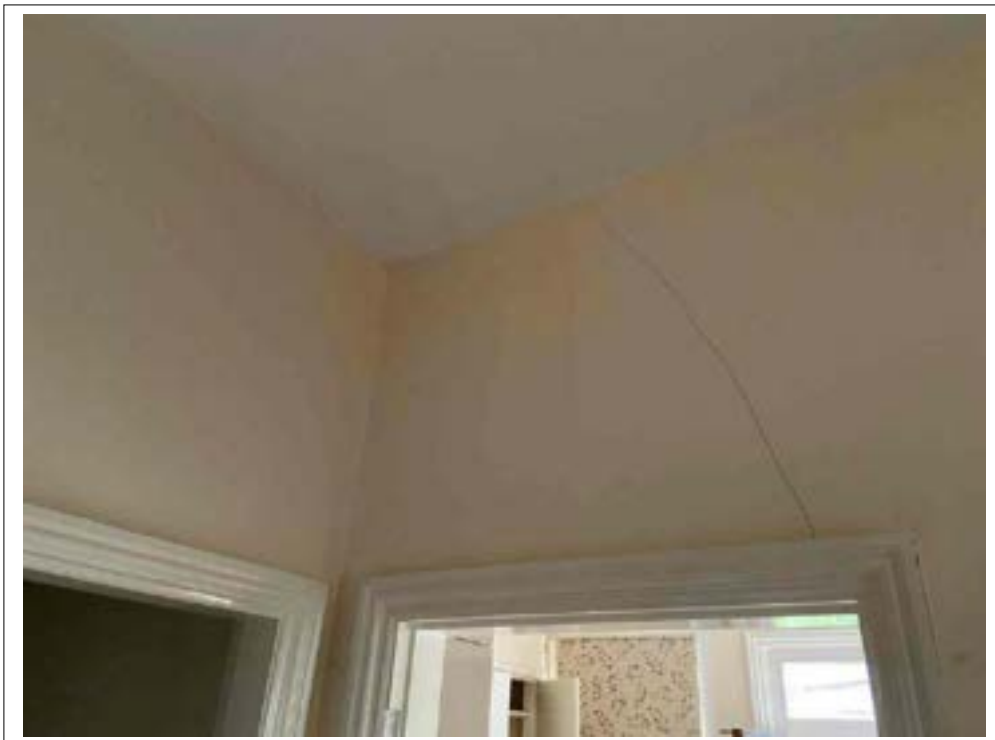
126. Crack noted internally.

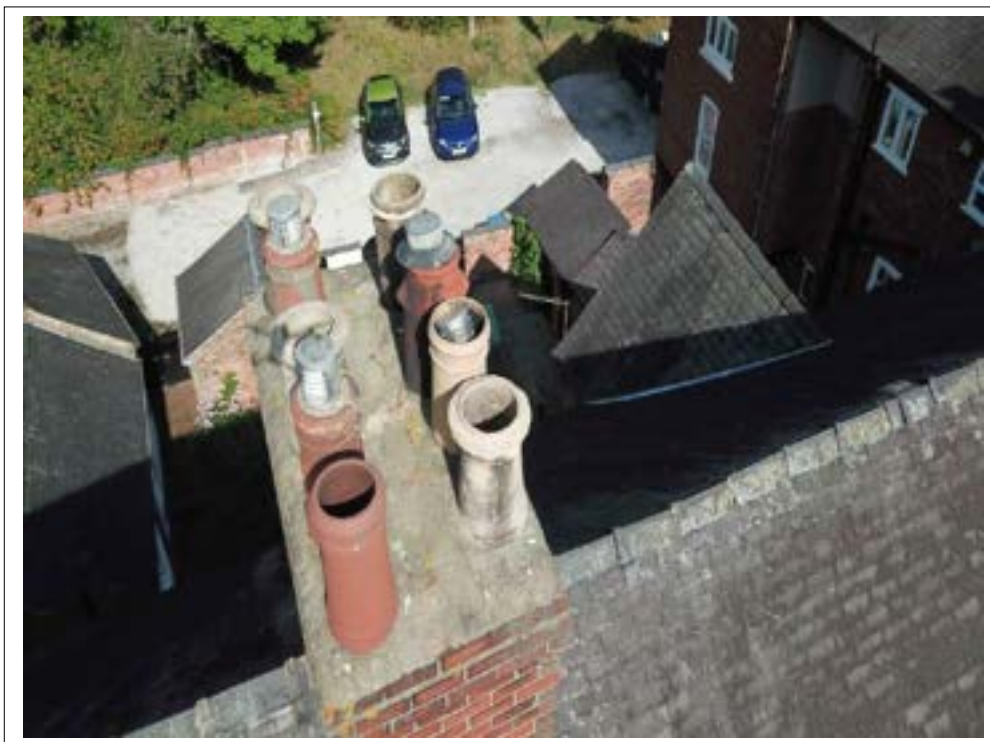
131. Cracking to cement flaunching.

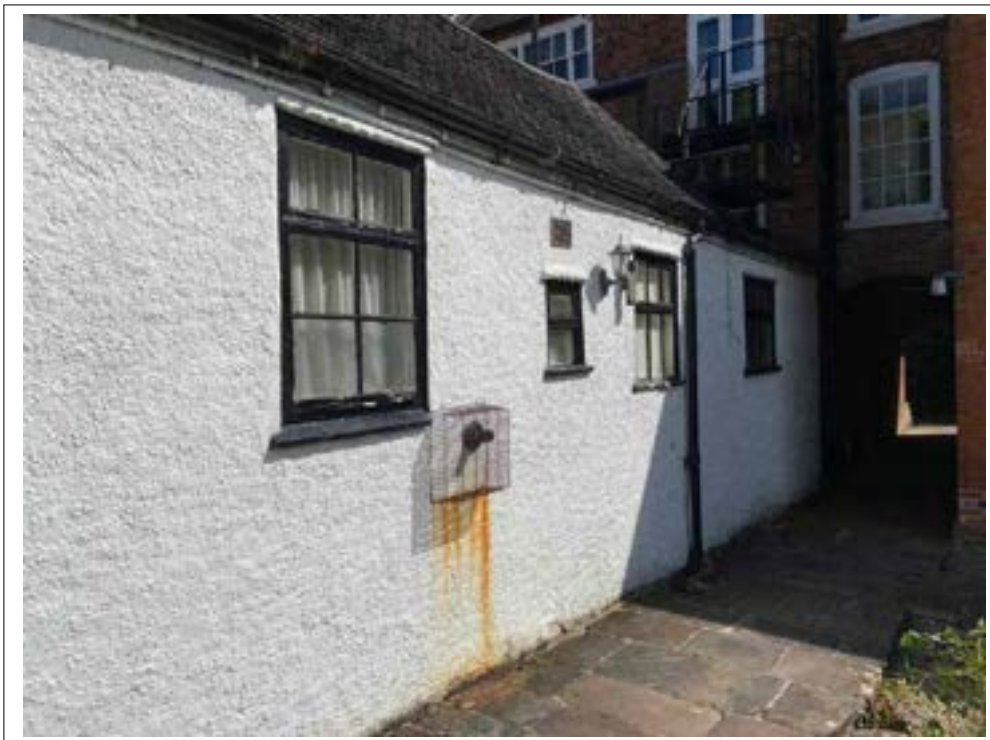
137. Corrosion to flue cage resulting in staining to elevation.

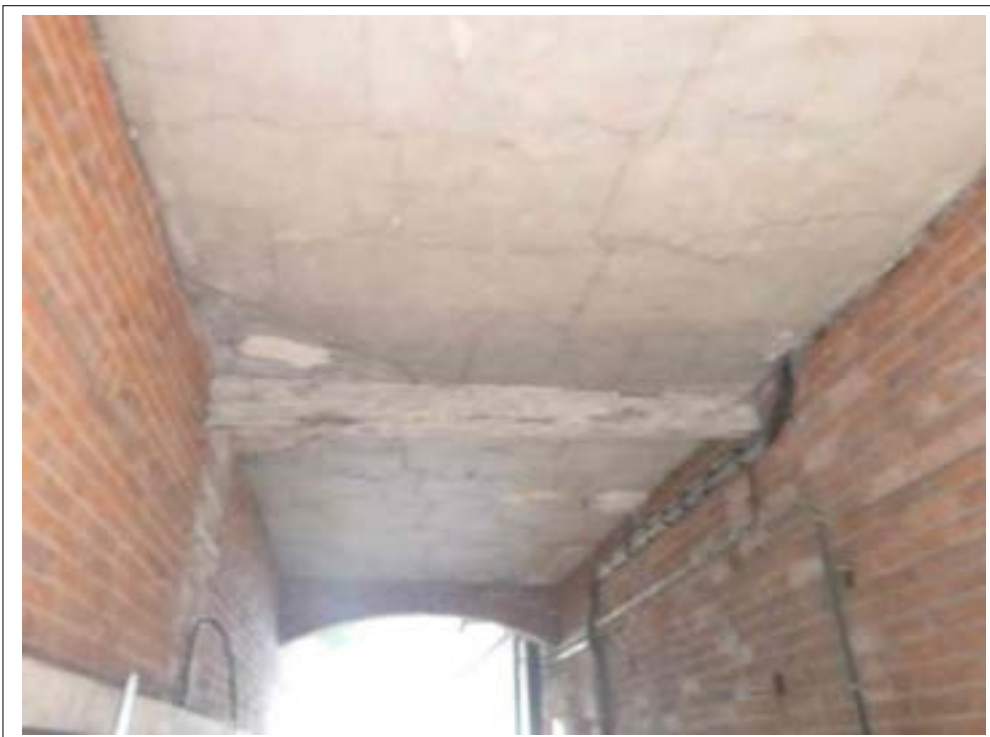
138. Cracking noted to alleyway soffit.

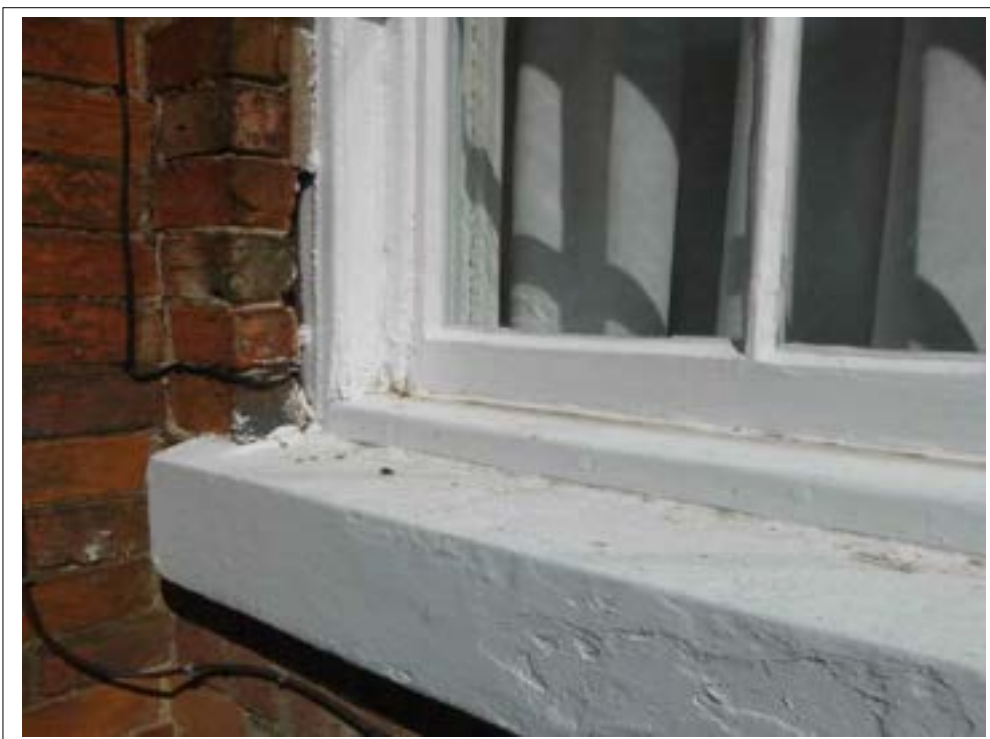
156. Missing mastic surround to window.

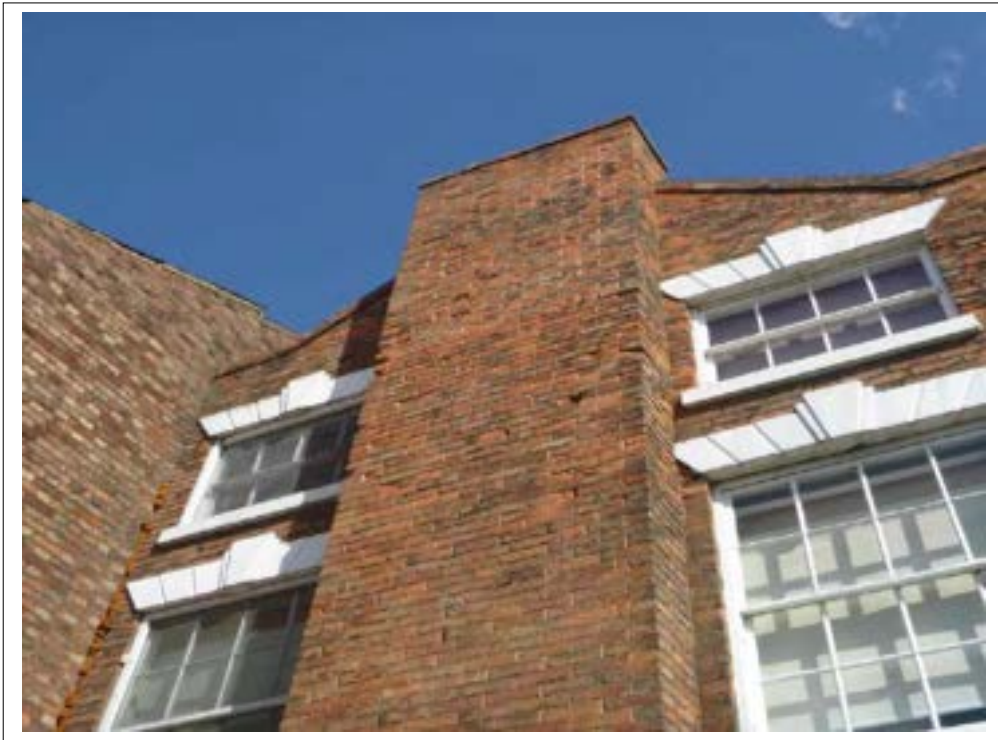
157. South elevation, weathered brickwork to high level.

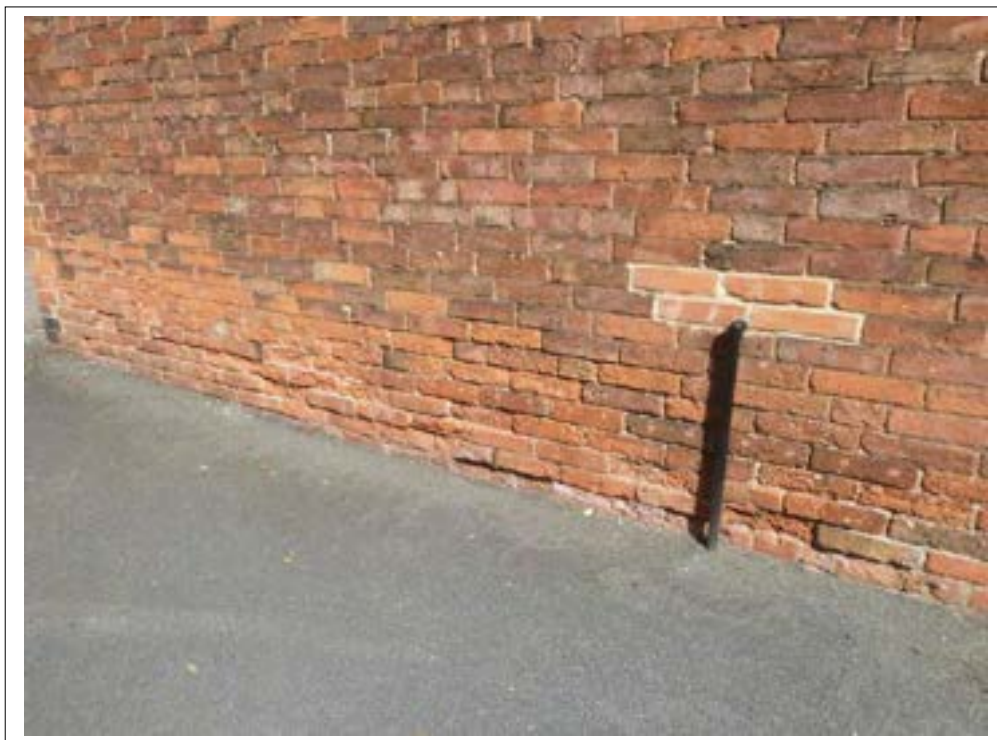
159. Frost erosion to brickwork.

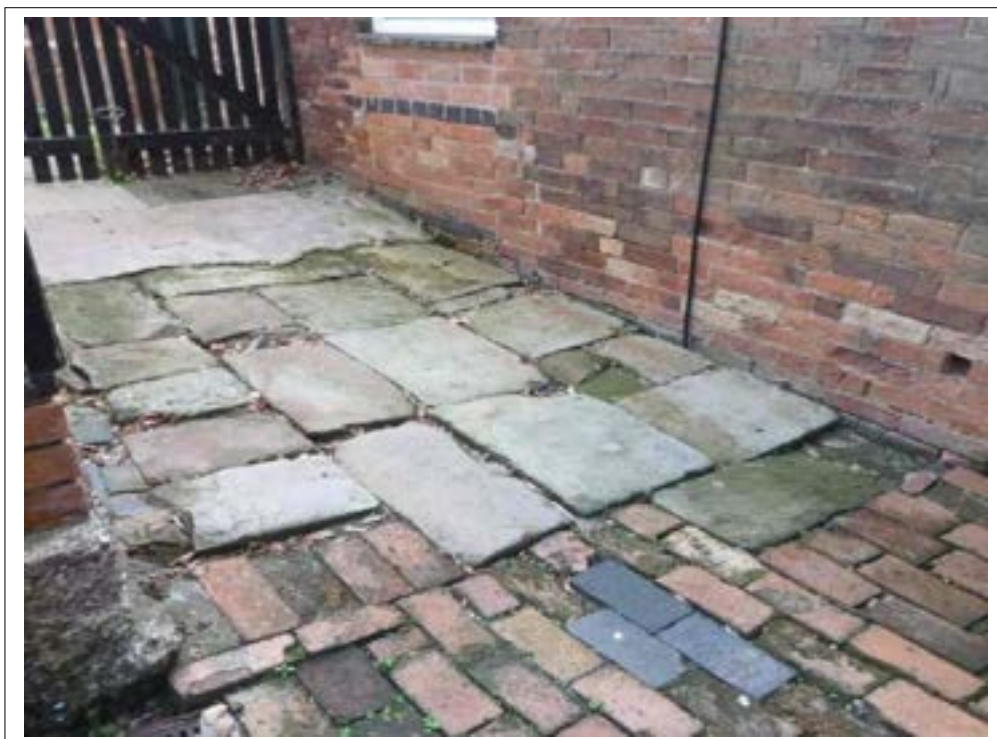
160. Undulating paving surface to rear pathway

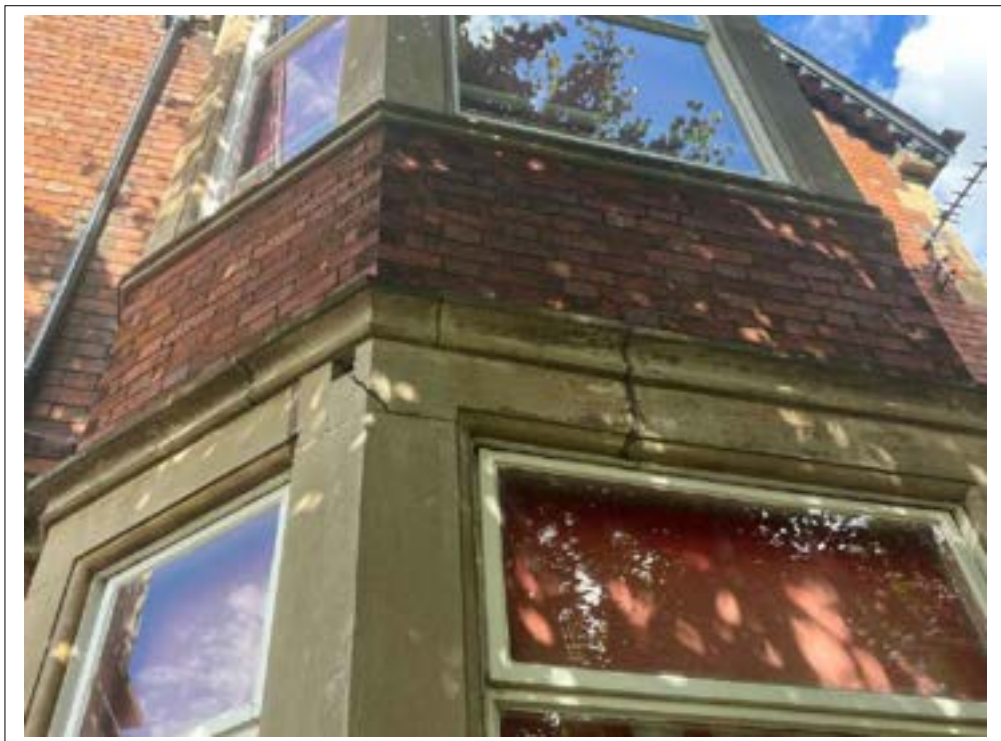
178. Cracking noted to stone window surround.

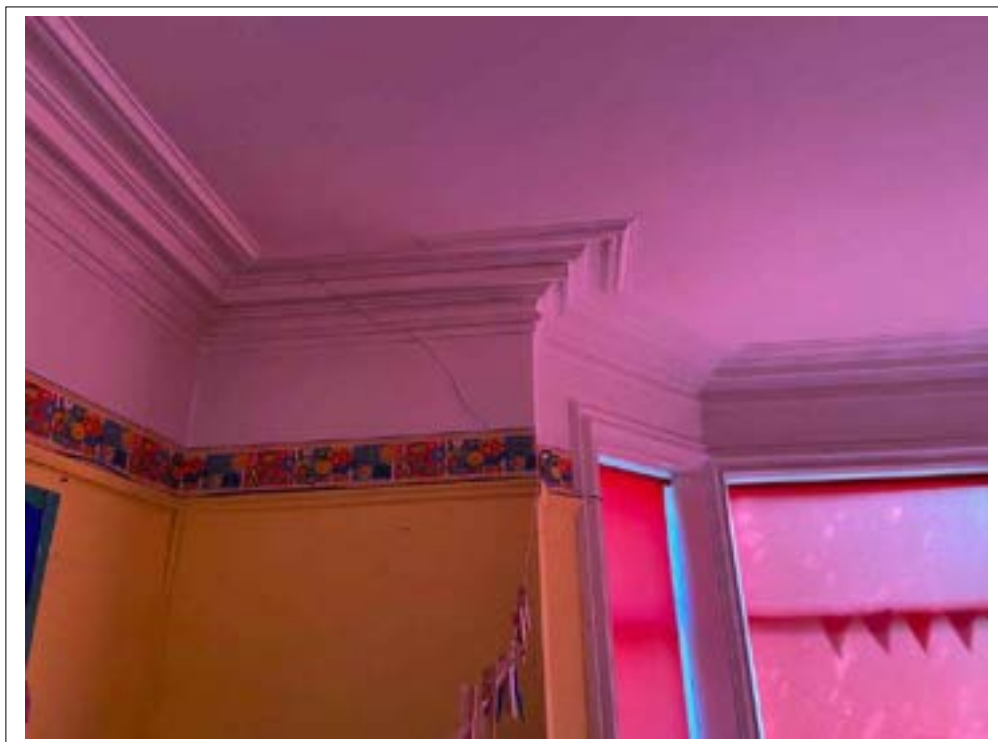
185. Cracking noted internally to front bay.

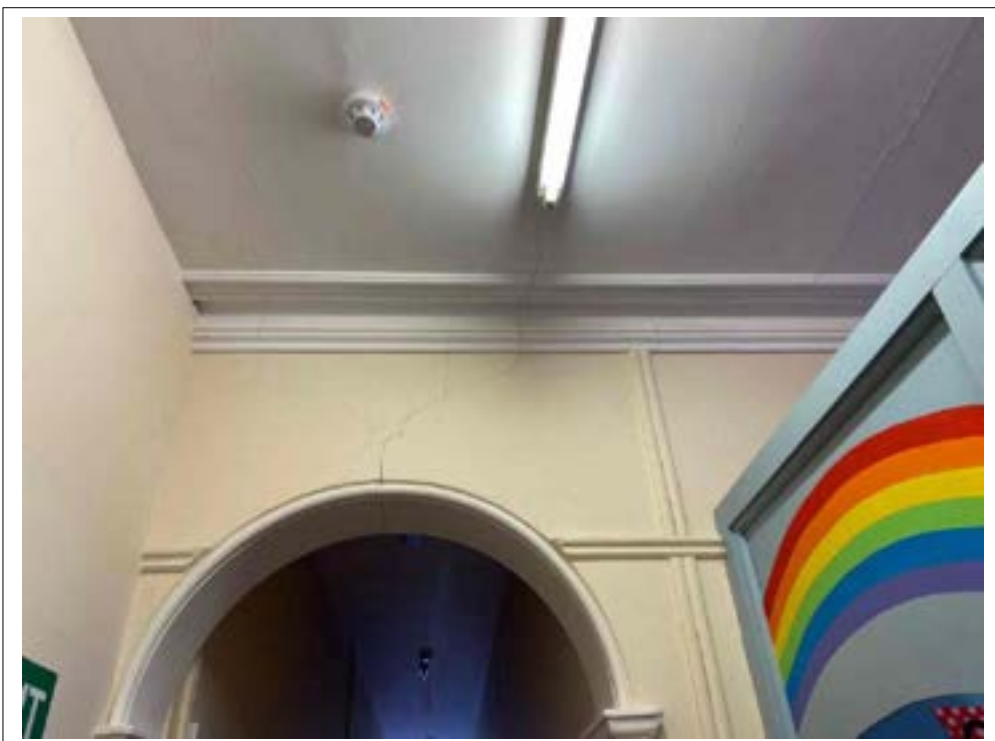
190. Cracking noted internally.

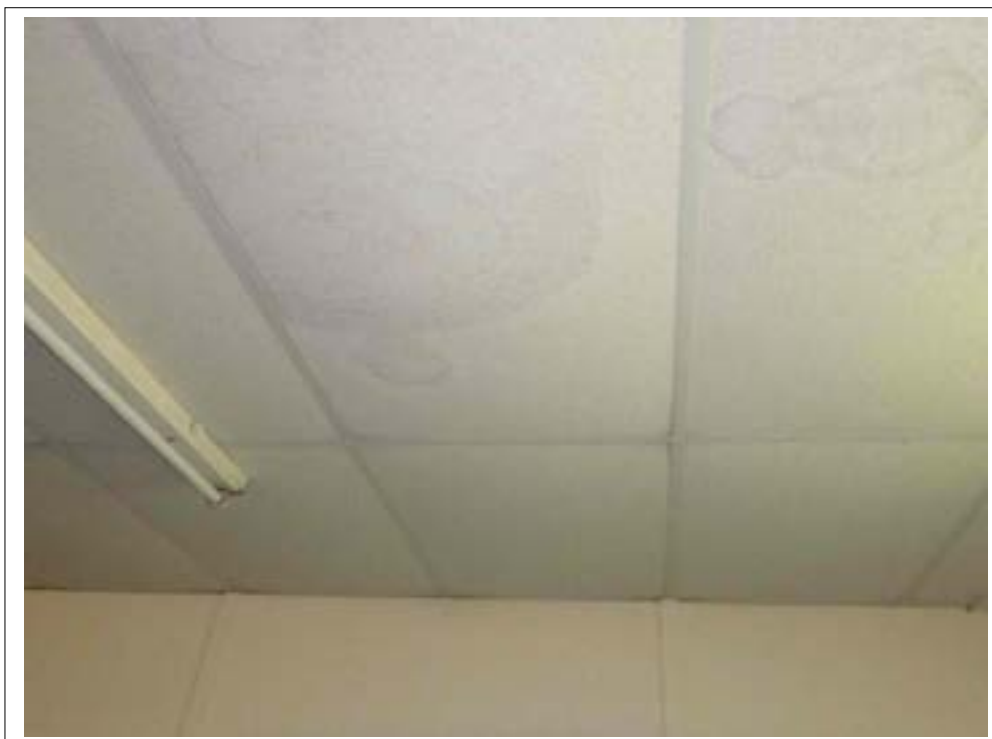
200. Staining noted to ceiling tiles.

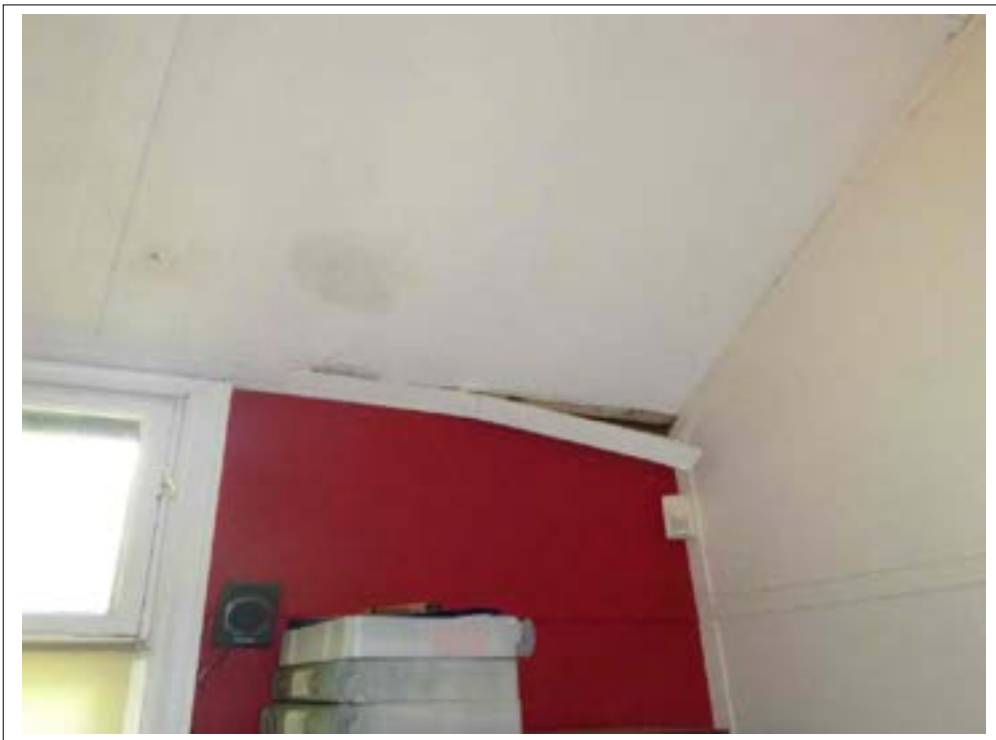
201. Ingress noted to ceiling.
