**EXECUTIVE SUMMARY
PRE ACQUISITION
SURVEY REPORT**

**OCKBROOK SCHOOL
THE SETTLEMENT
OCKBROOK
DERBYSHIRE
DE72 3RJ**

Date: 16 September 2022

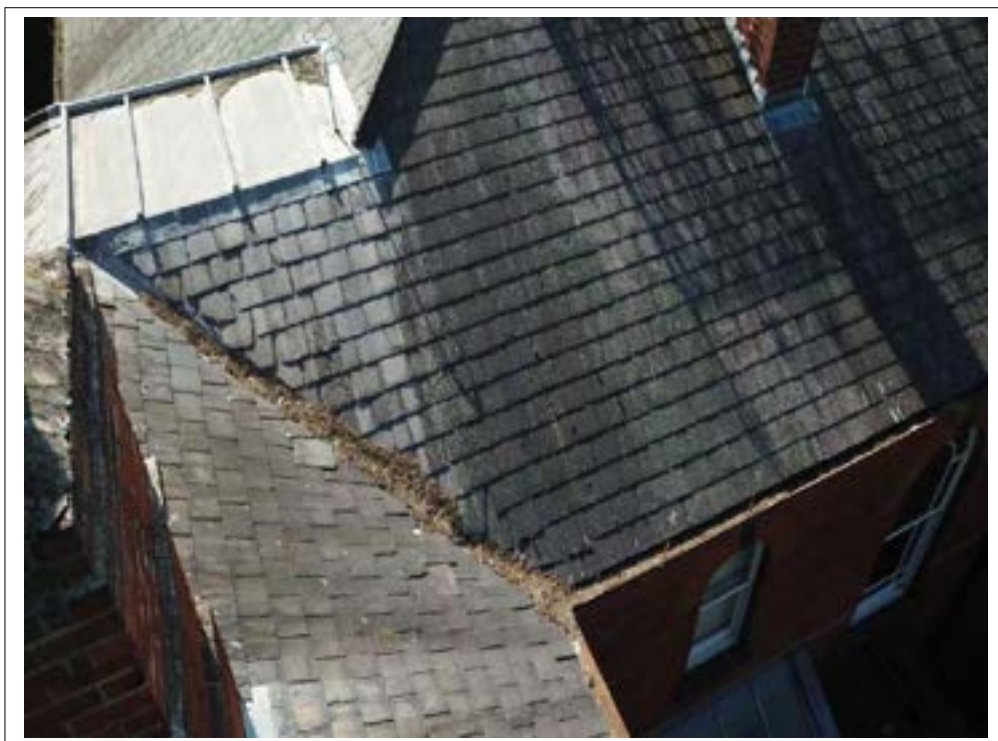
4. Vegetation build up to rainwater goods.

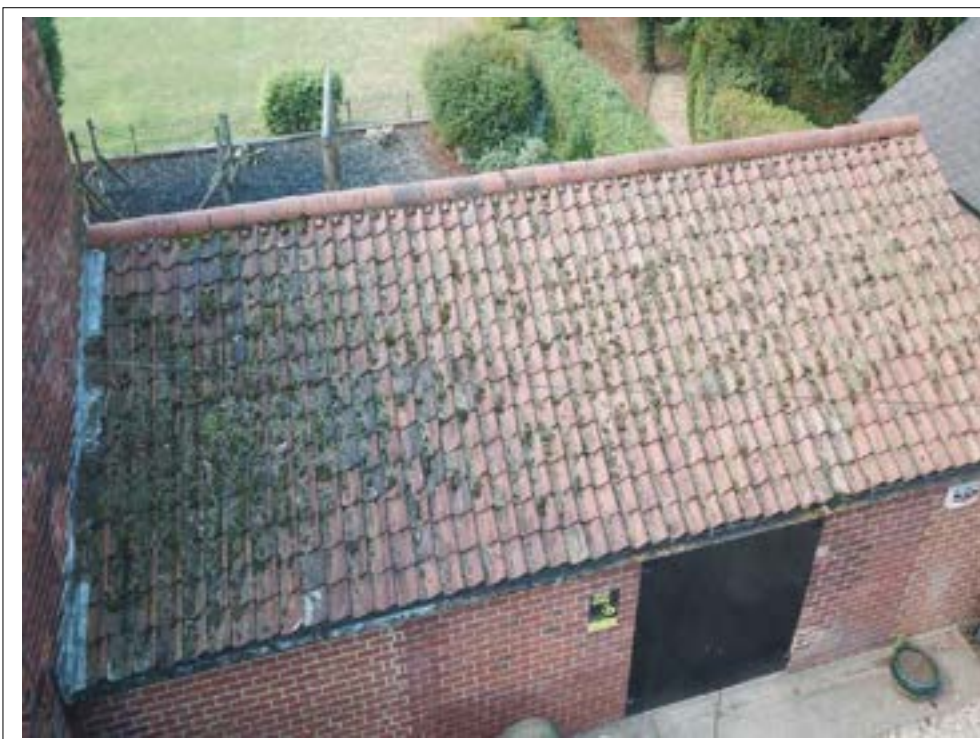
6. Foliage build up to roof covering.

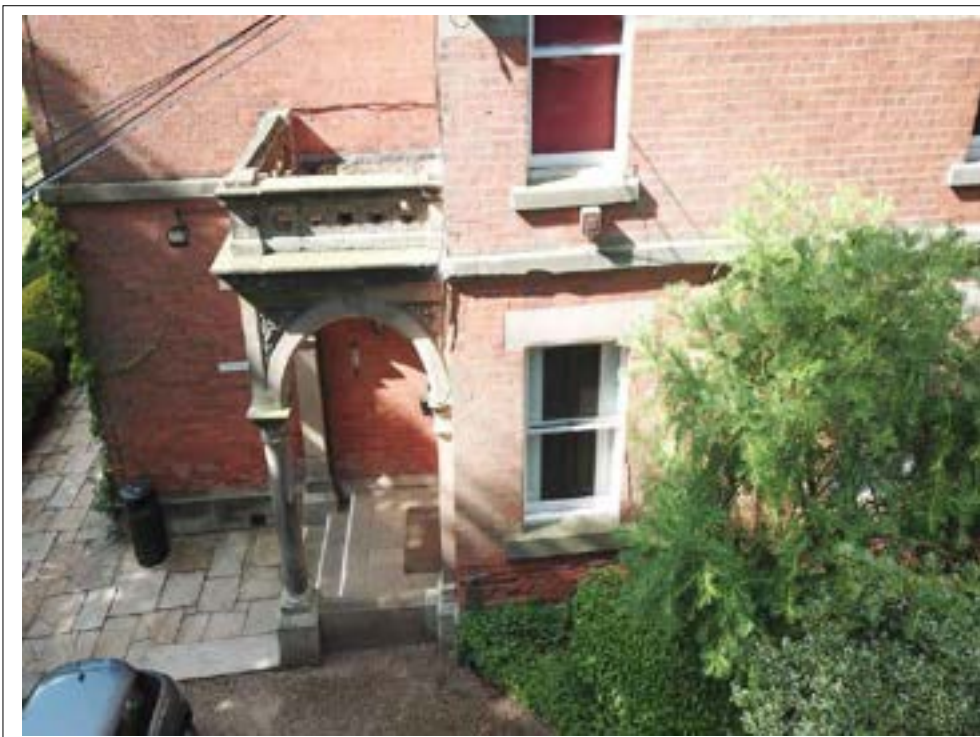
8. Cracking noted to Northeast corner.

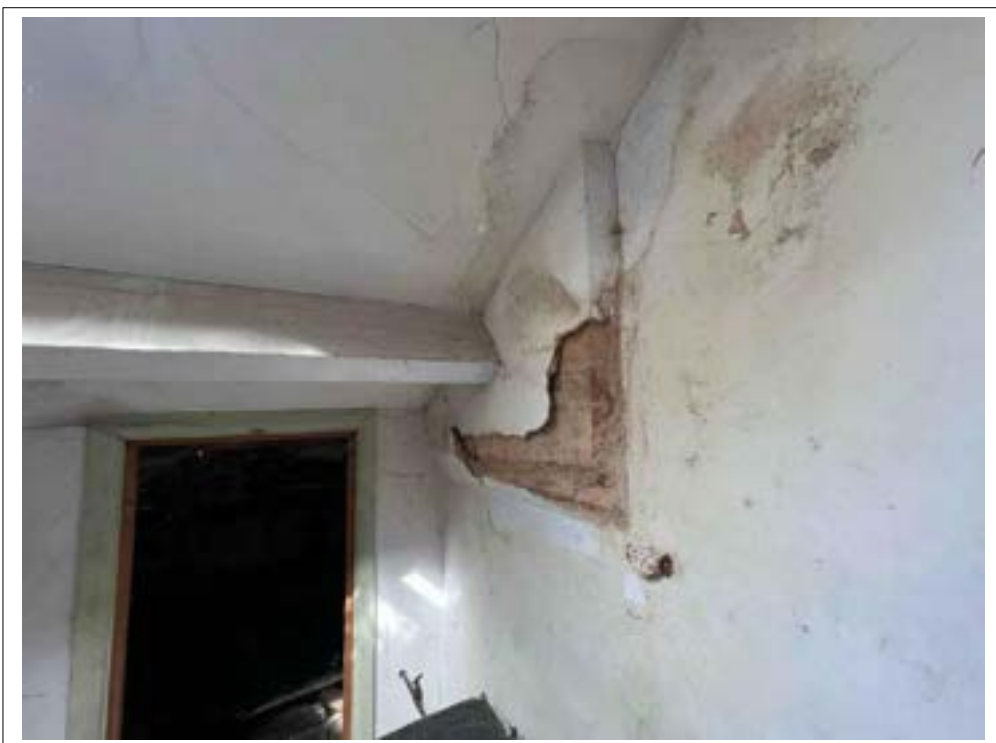
14. Damp ingress and blown plaster.

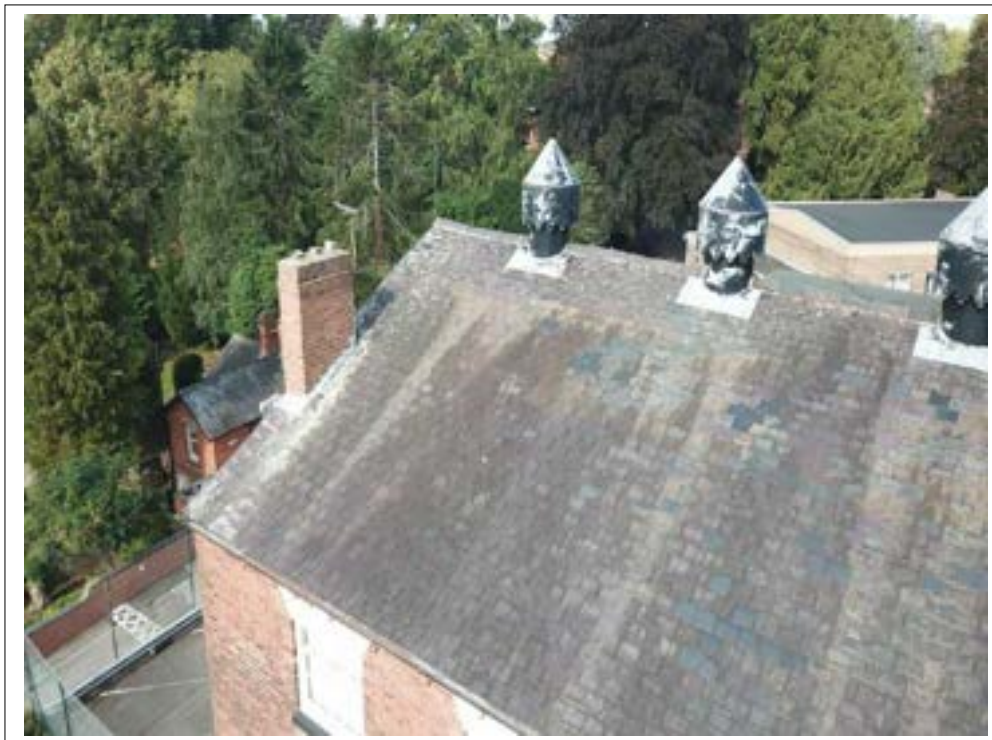
23. Redundant flues

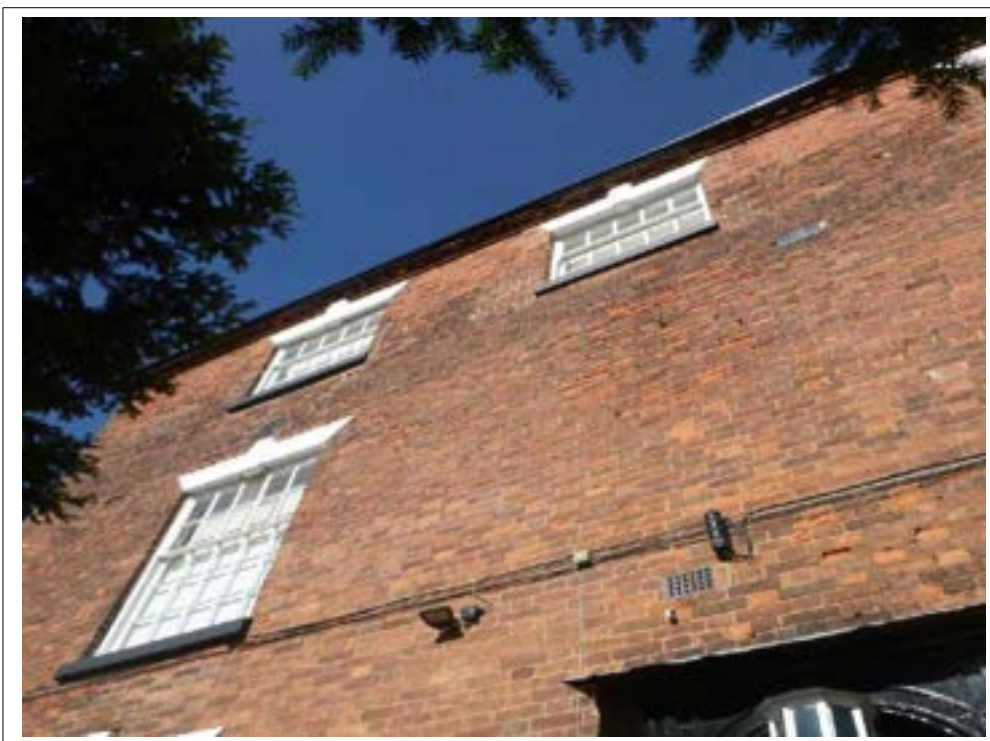
26. East elevation, weathered brickwork.

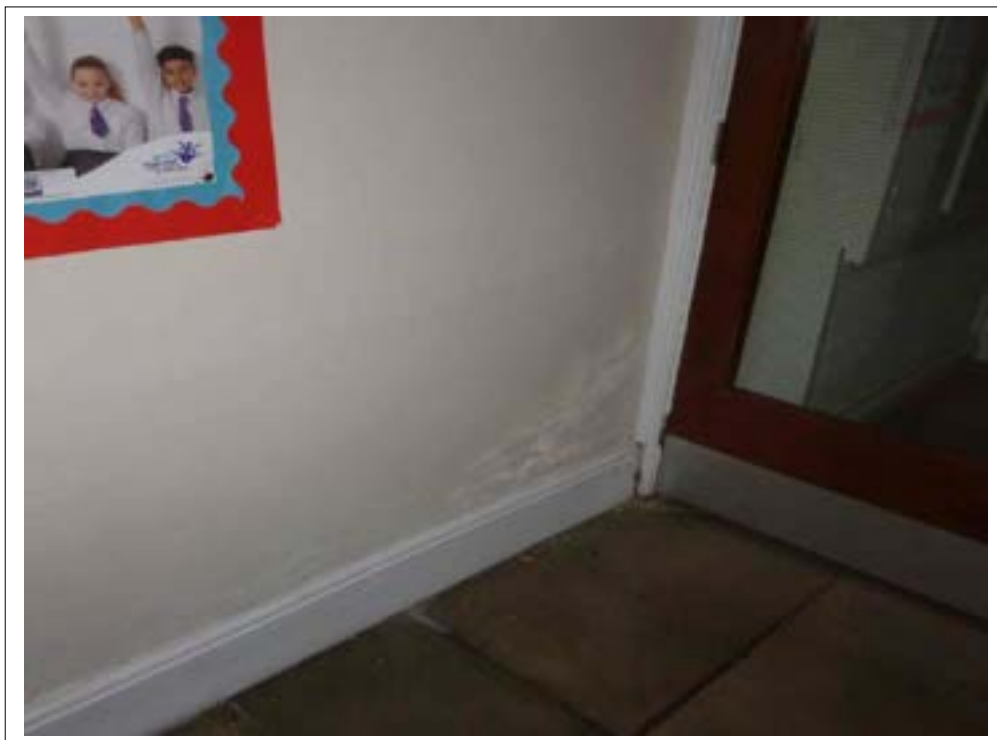
44. Isolated areas of damp ingress present at low level.

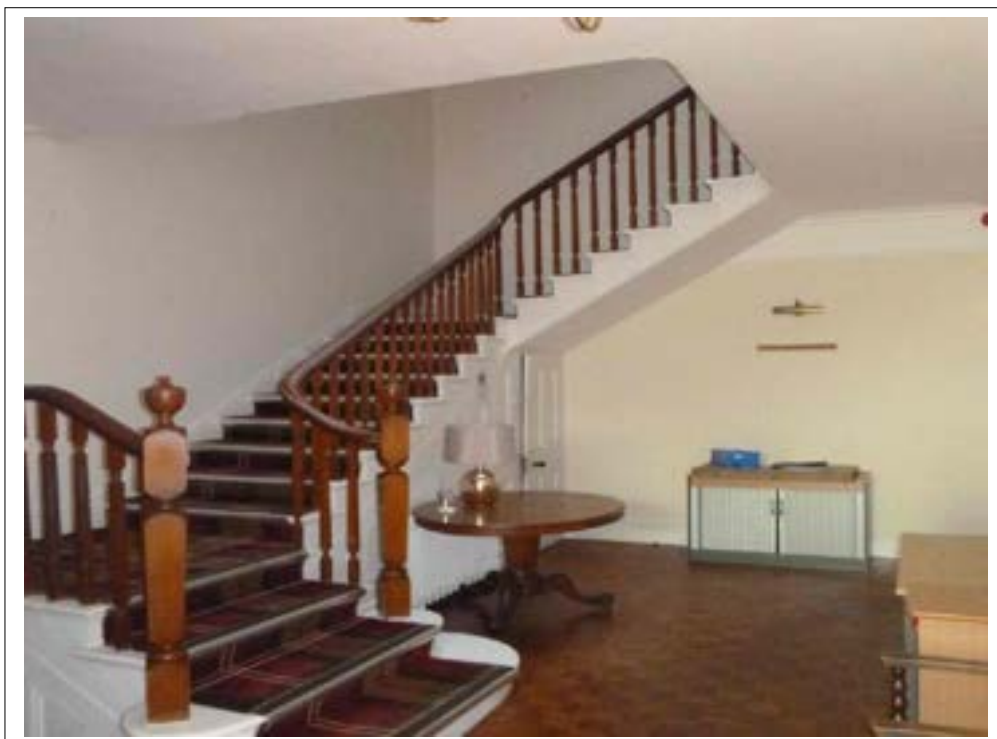
45. Staircase from ground to first floor.

A large hardwood timber staircase exists providing main access between ground and first floor, however, secondary stair access is noted which is of a more modern single flight timber specification.

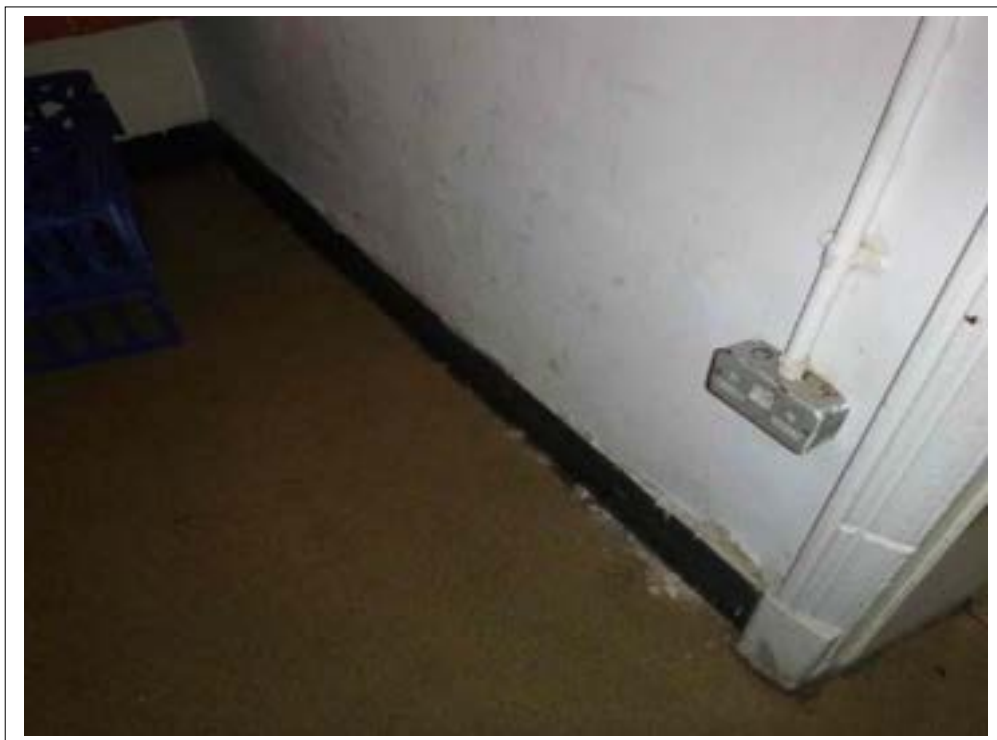
46. Isolated areas of damp ingress present at low level.

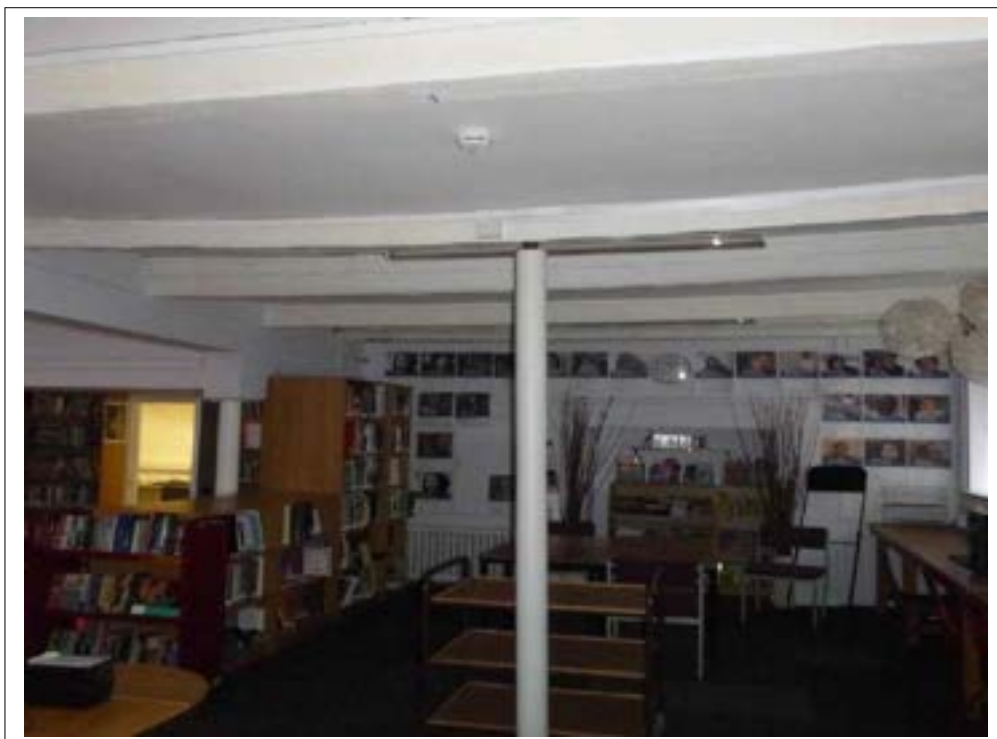
47. West extension, south wing, interim steel support to timber floor.

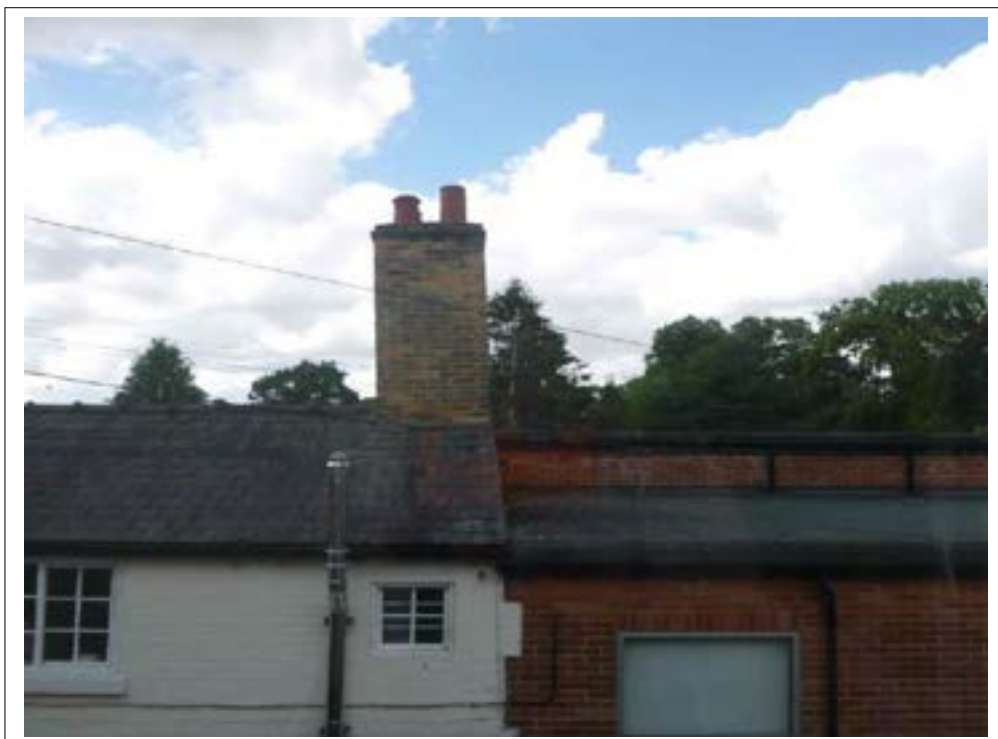
55. Leaning chimney.

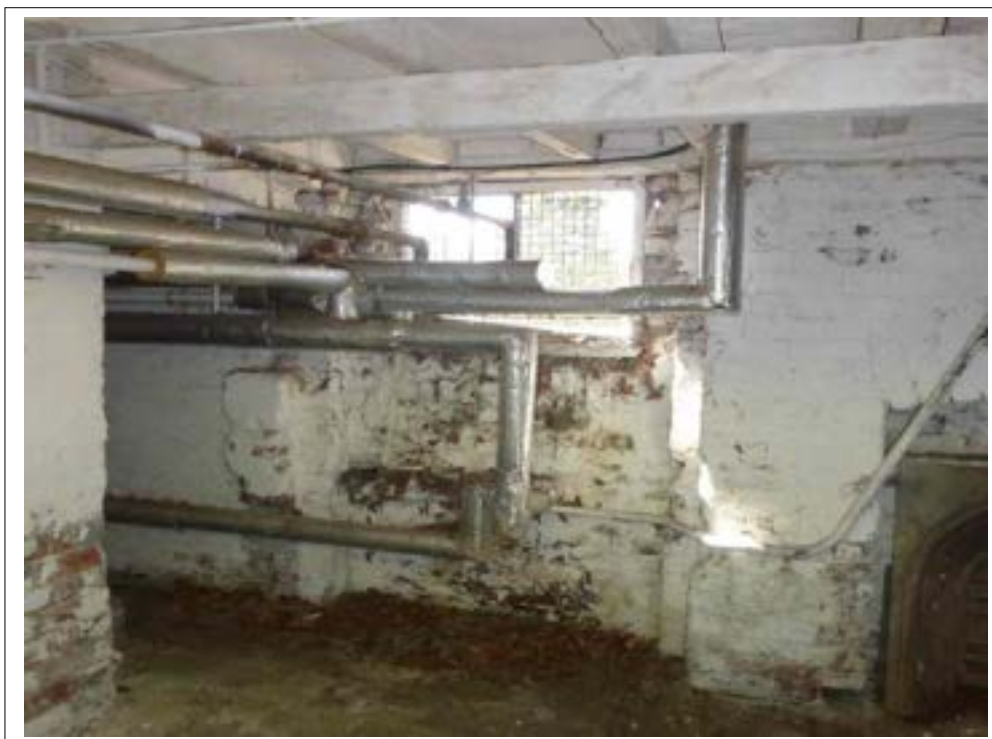
65. Damp ingress to basement.

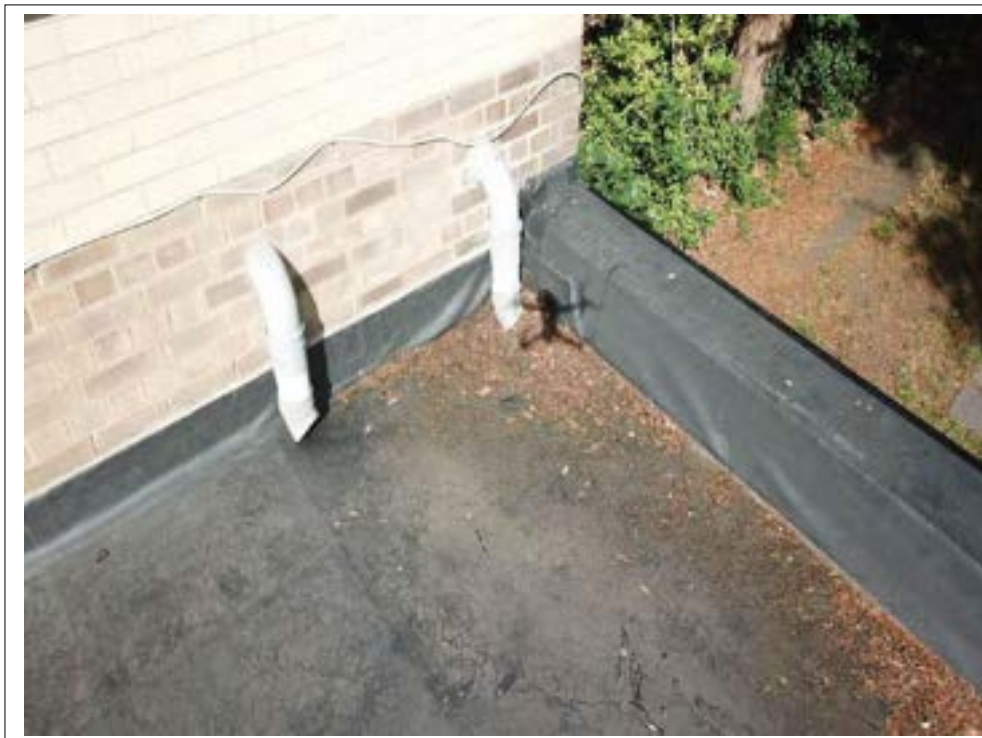
67. Single ply membrane lifting.

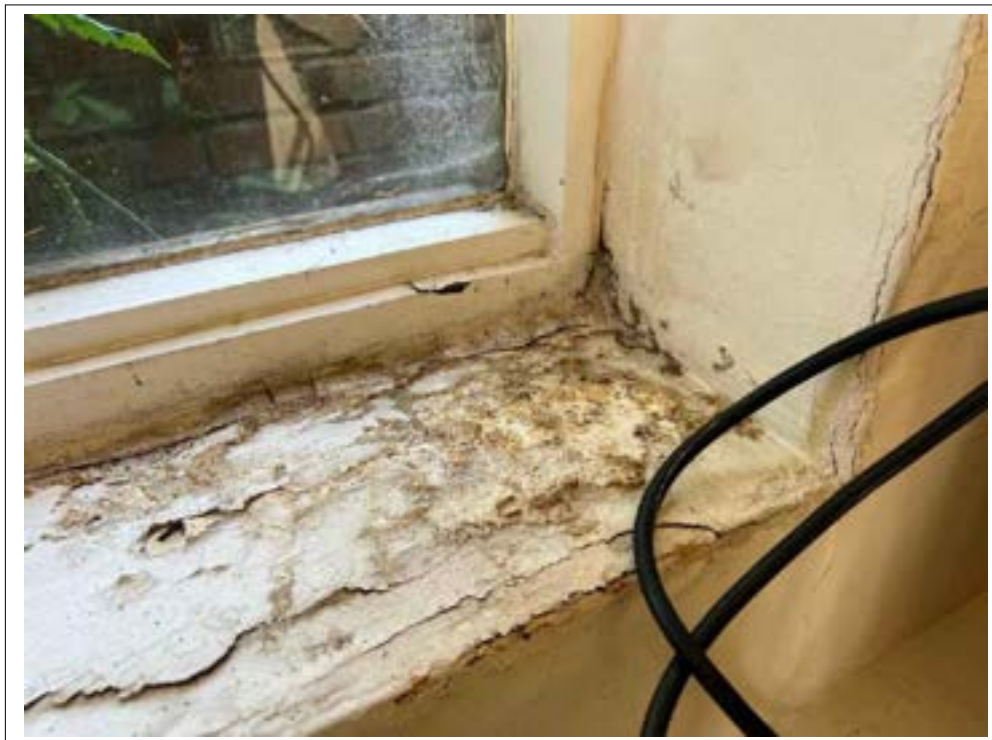
73. Damp ingress to West elevation window reveal.

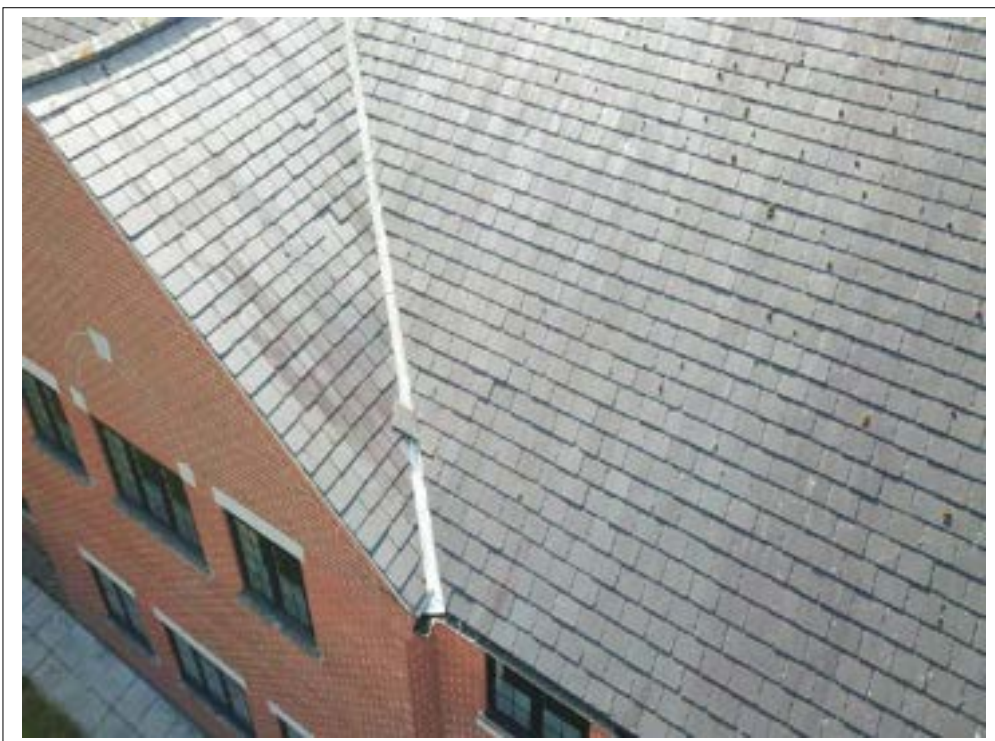
77. Slipped slate to valley gutter.

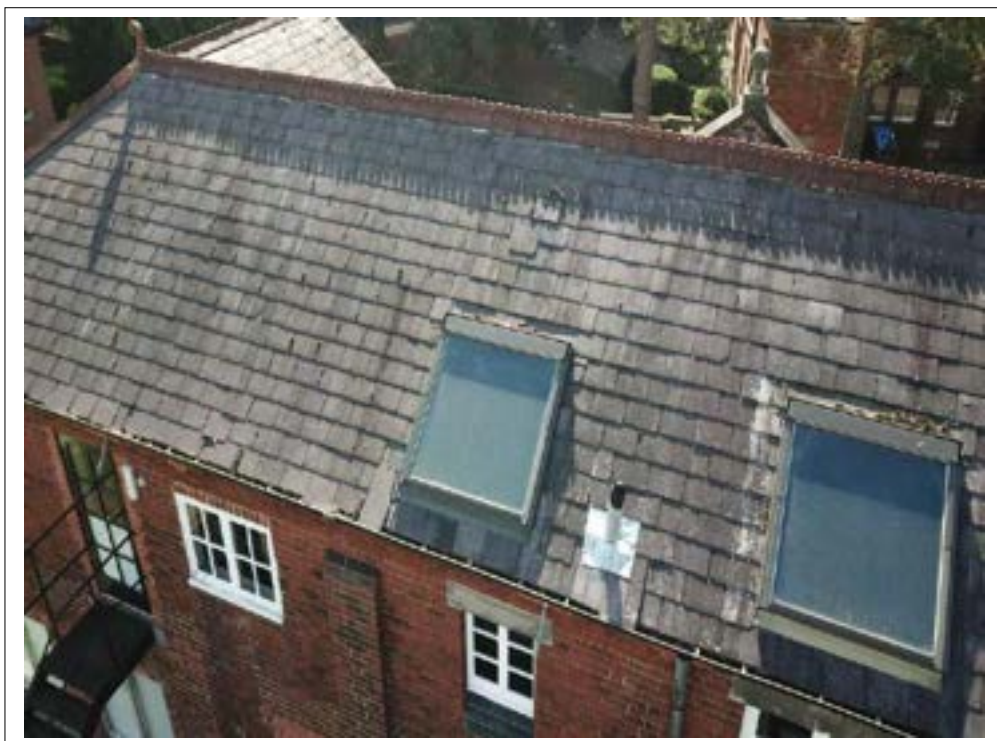
88. Slipped slates to roof covering.

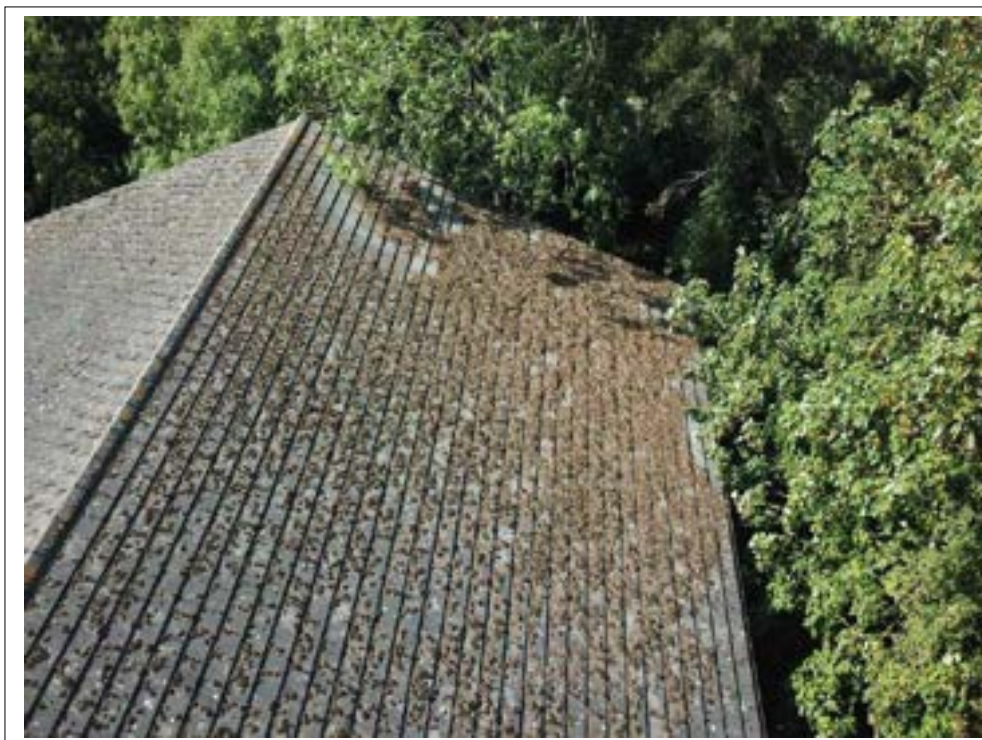
100. Foliage to roof covering.

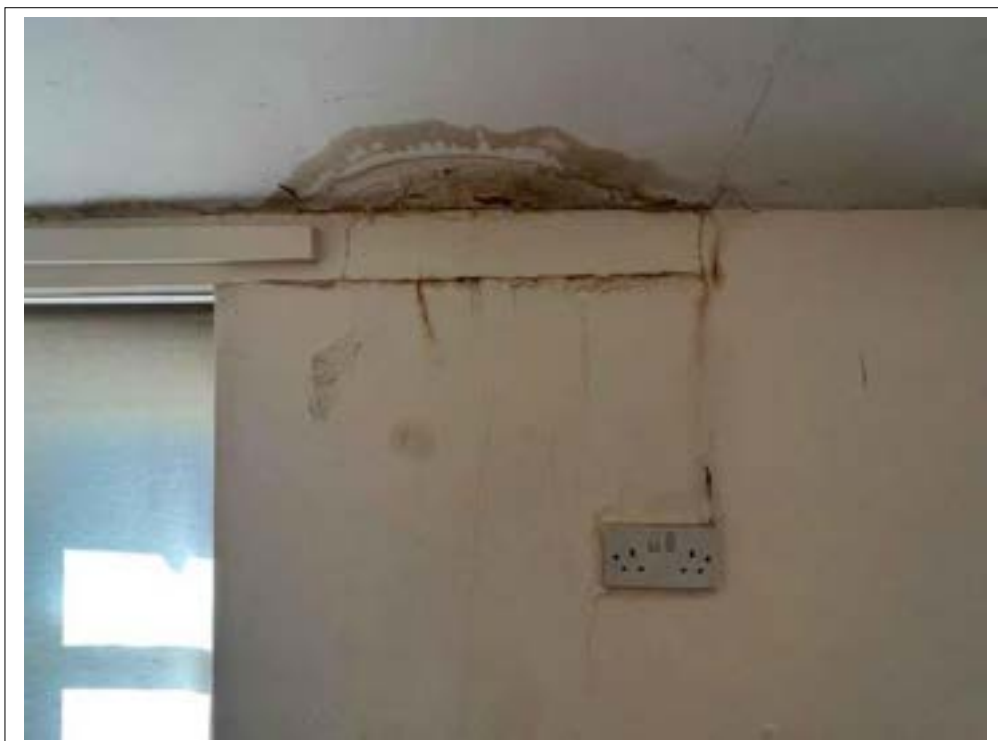
115. Water ingress to rear extension.

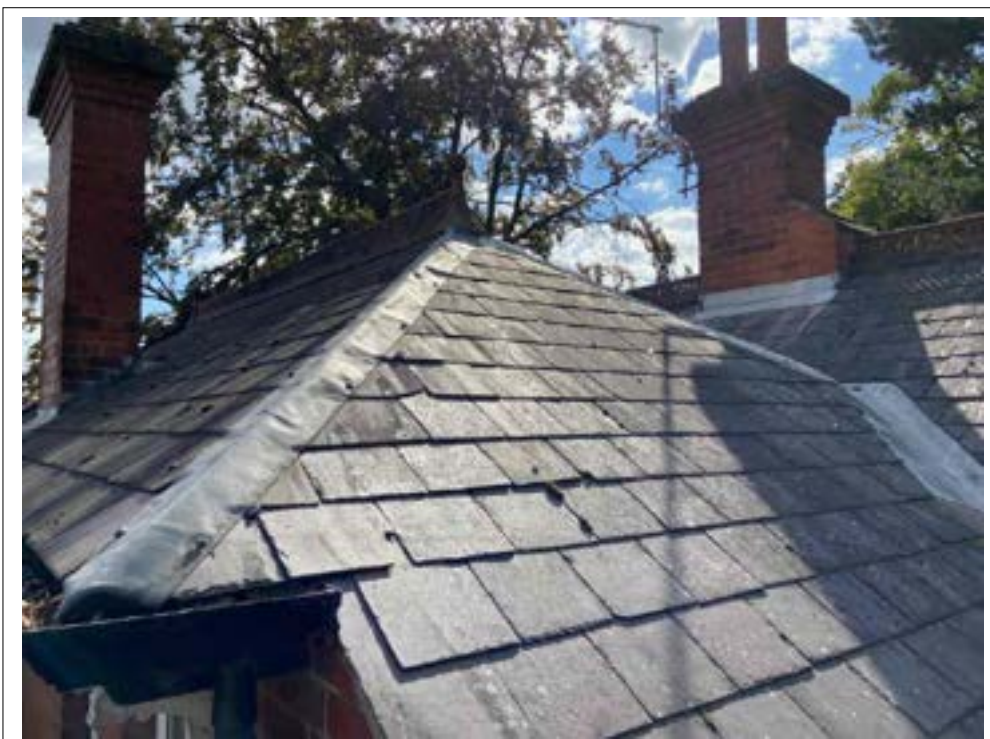
121. Mechanically fixed hip flashing.

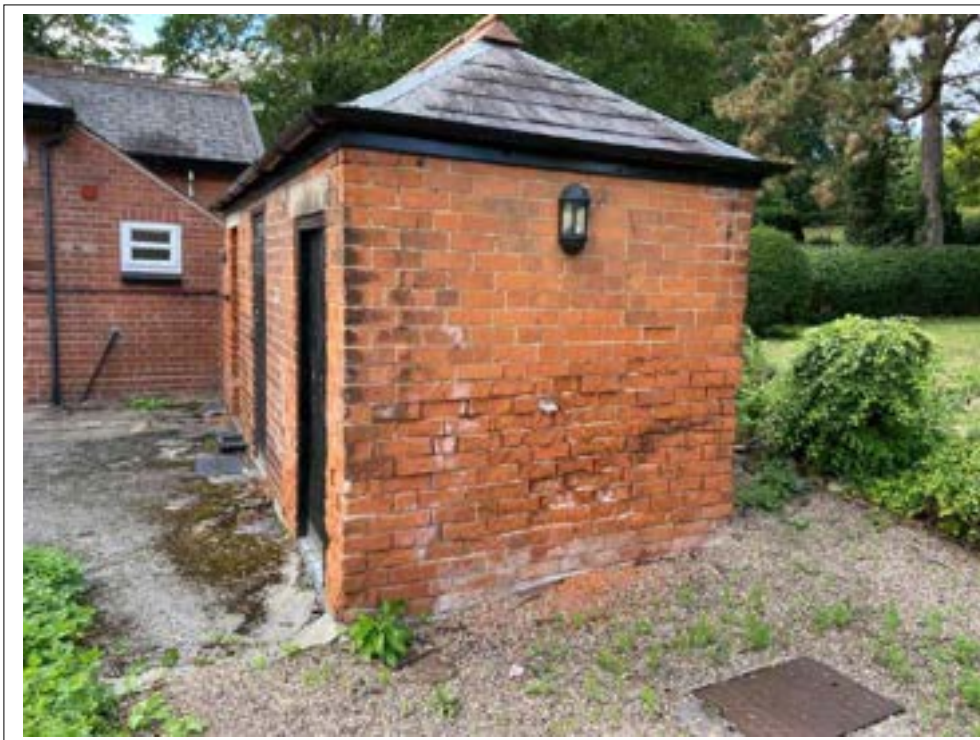
124. Frost erosion to brickwork to outhouse.

47.	Roof overhaul	3,000.00					
48.	External redecoration. Tenant to redecorate all non-window related joinery.	3,500.00			500.00		
49.	Isolated brickwork repairs	2,000.00

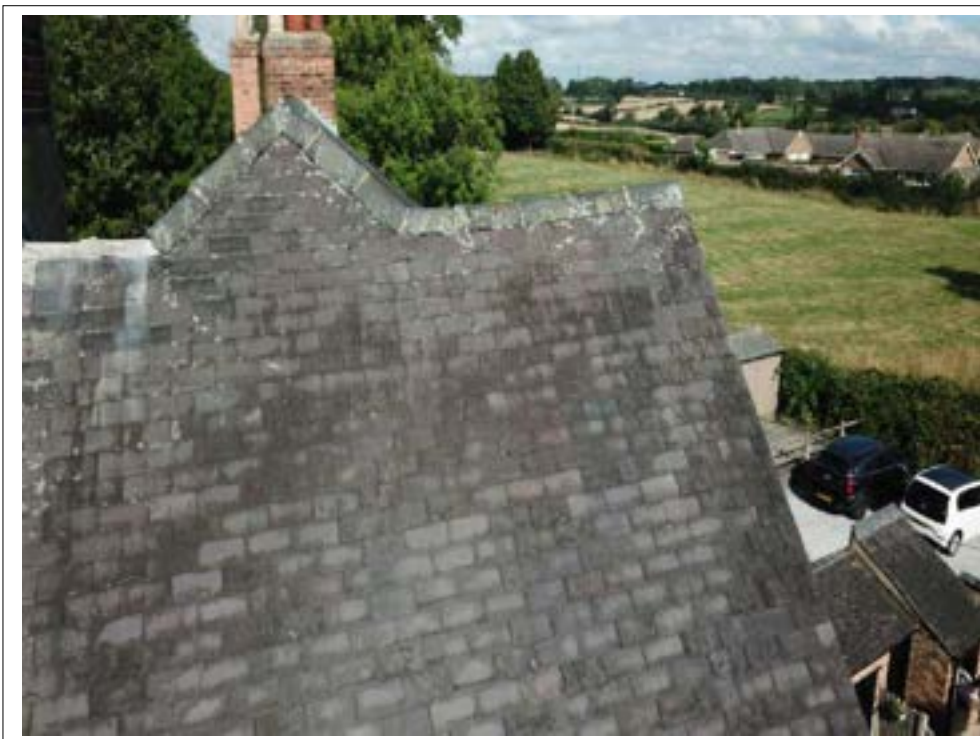
134. Soiling and lichen growth to ridge.

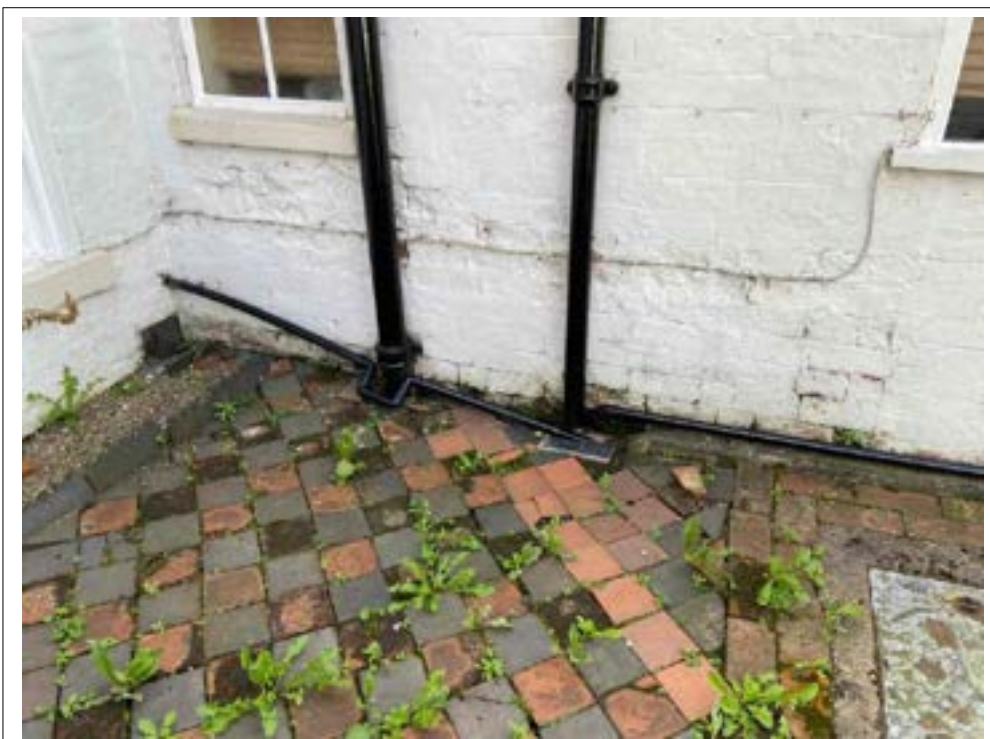
144. Paving to yard, weathered brickwork to elevation.

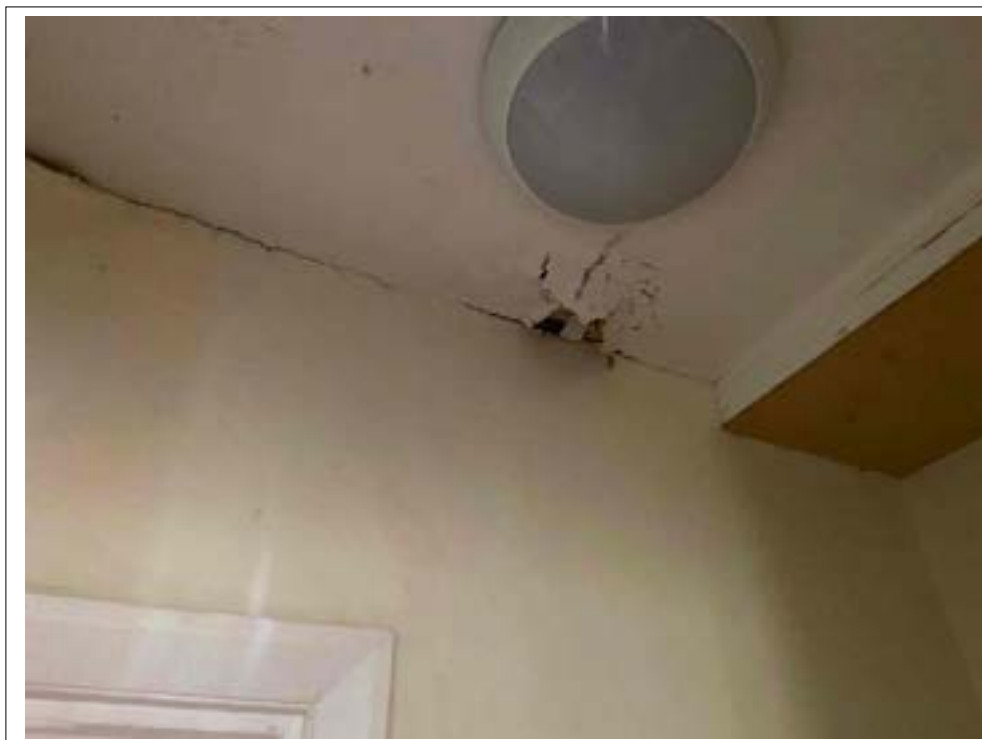
145. Damp ingress to ceiling.

53.	Redecoration to rear exit stairflight				2,000.00		
54.	Plaster repairs to areas of low level damp ingress	1,500.00					
	Sub Total	5,500.00	5,000.00	0.00	2,000.00	0.00	0.00
	Broadstairs

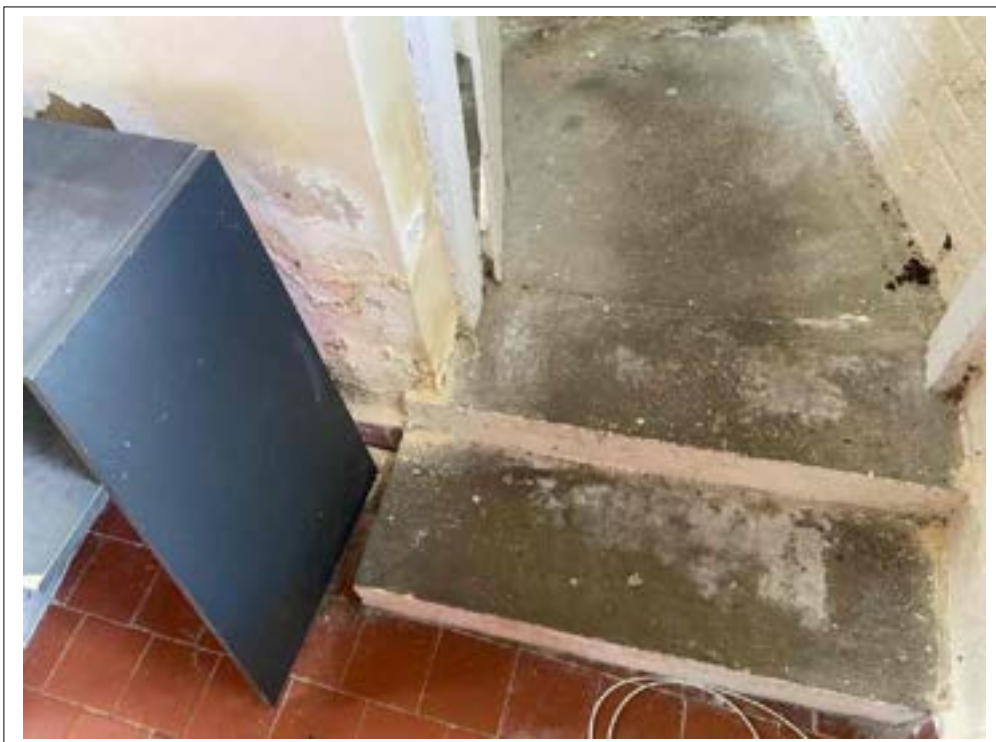
149. Isolated damp ingress to west extension laundry room.

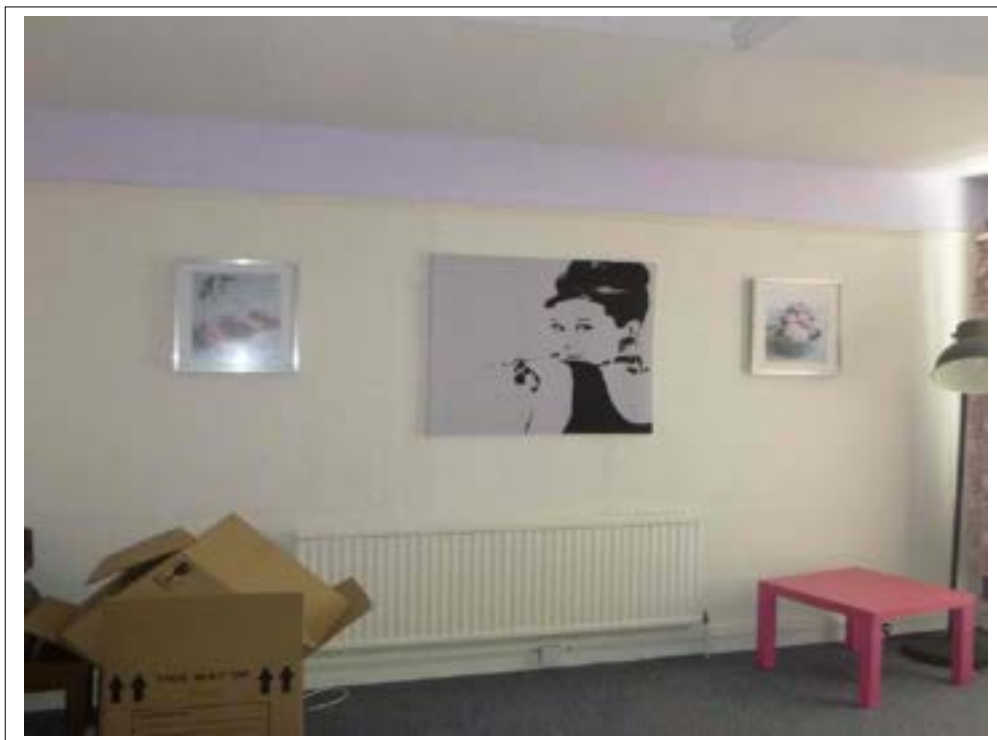
165. Main lounge. Infill former window opening to party wall.

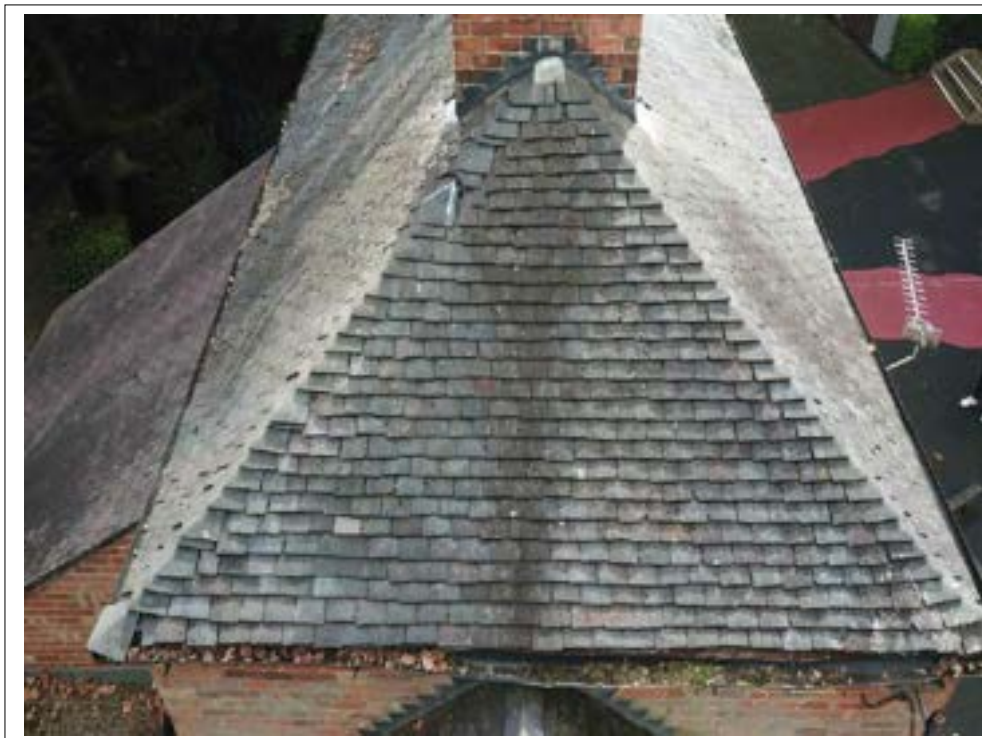
173. Poor slating to Mews House.

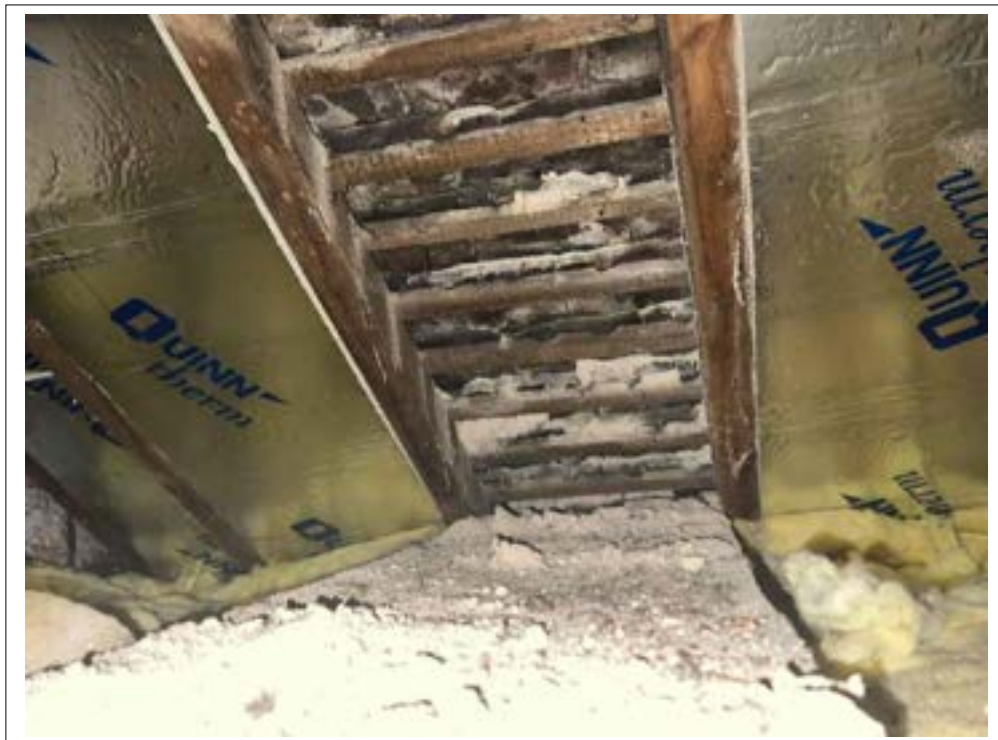
183. Roof void with rigid board insulation present.

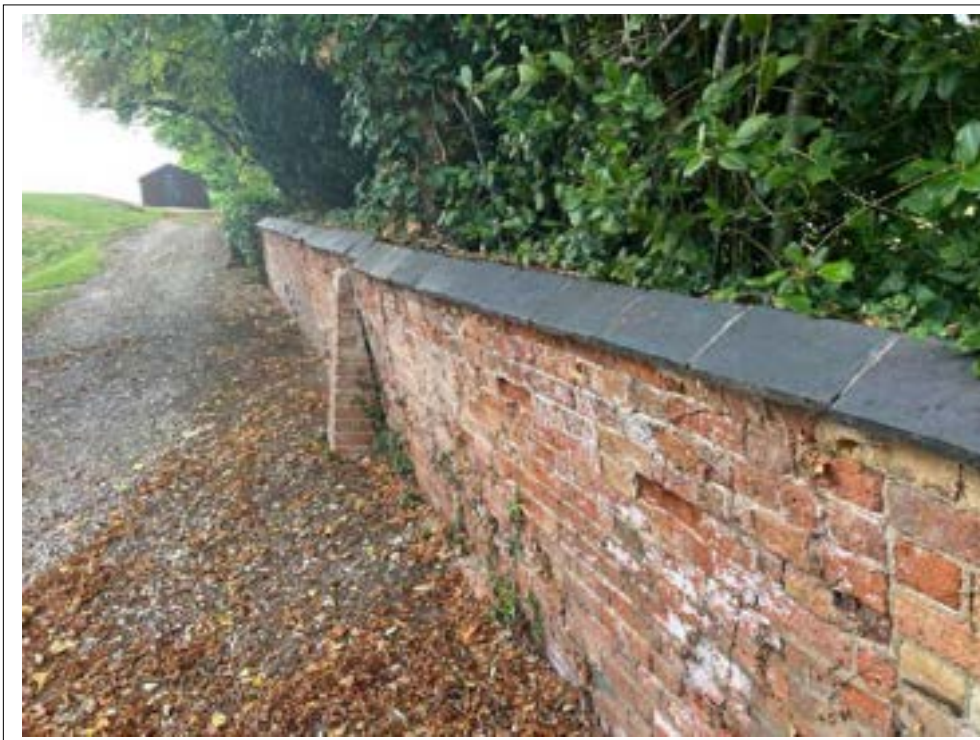
206. Wall leaning.

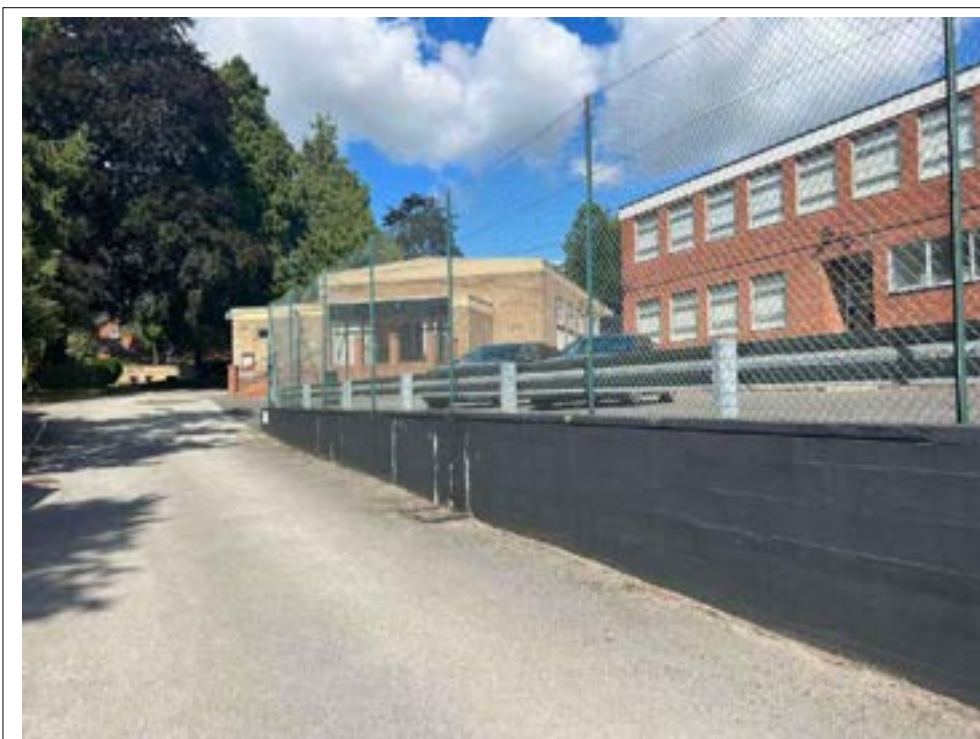
207. Retaining wall to tennis courts and hardstanding.

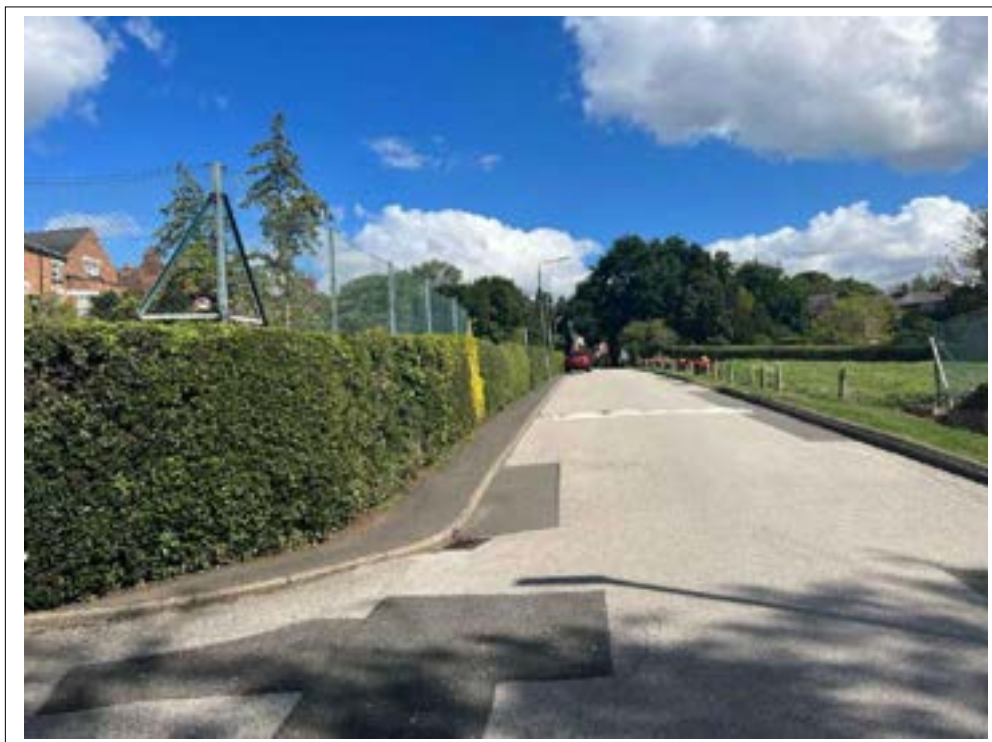
208. View looking up The Settlement.

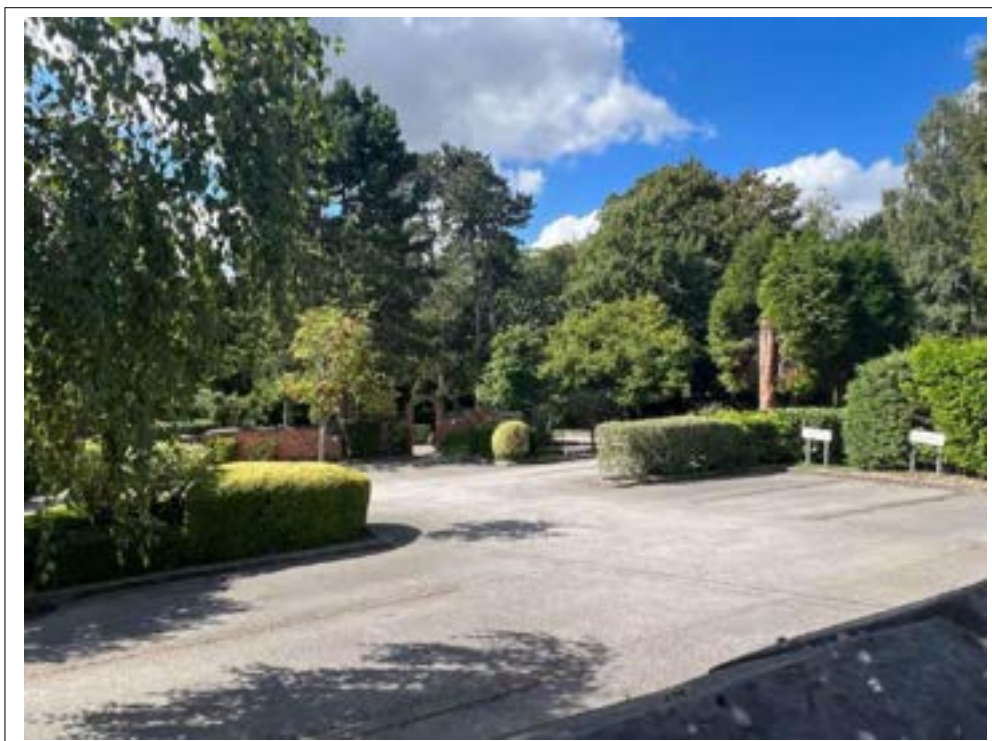
209. Car parking.
