**EXECUTIVE SUMMARY
PRE ACQUISITION
SURVEY REPORT**

**OCKBROOK SCHOOL
THE SETTLEMENT
OCKBROOK
DERBYSHIRE
DE72 3RJ**

Date: 16 September 2022

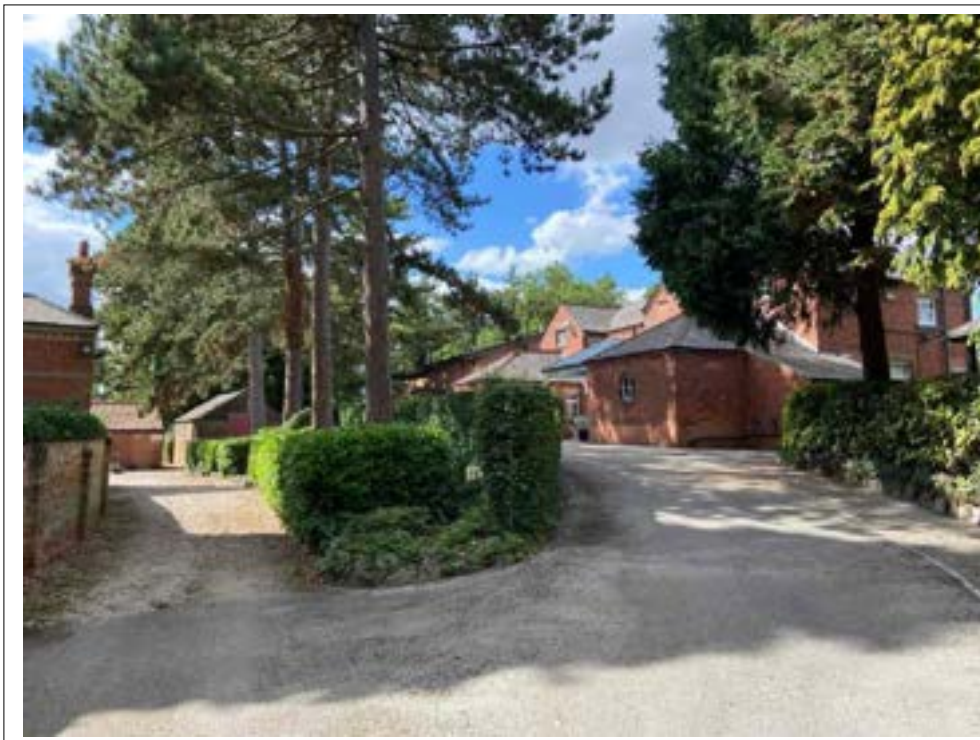
210. Drive leading to Mallelieu.

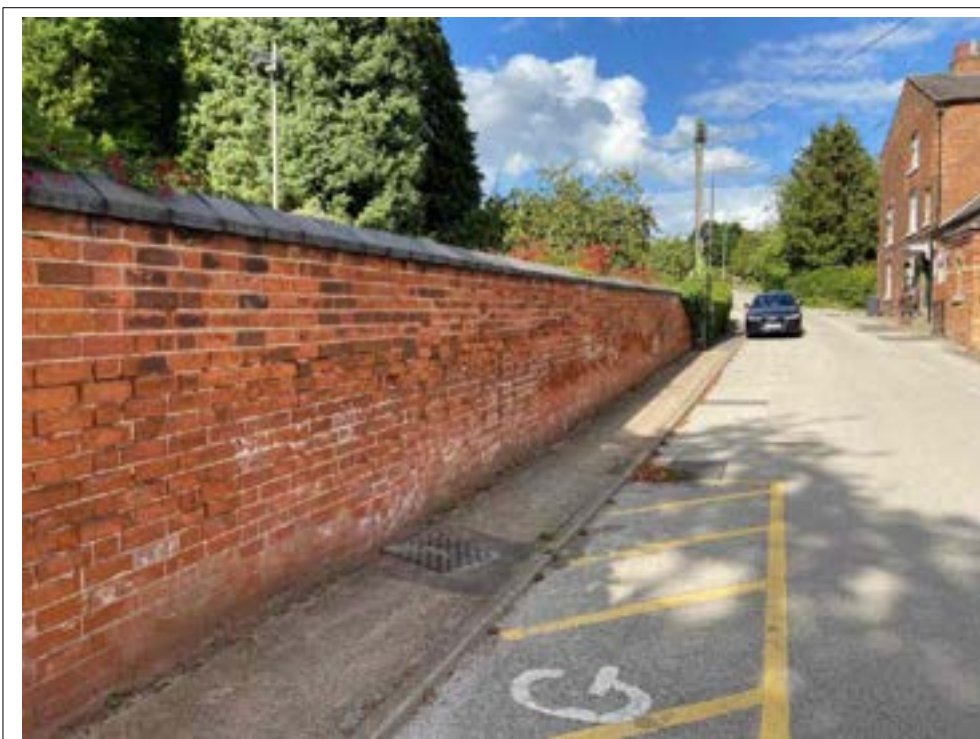
211. Boundary wall.
